**FINDINGS OF THE COMMITTEE APPOINTED TO
INVESTIGATE POWER SYSTEM FAILURES ON
NOVEMBER 29, 2021 AND DECEMBER 03, 2021**

ANNEXES OF THE FINAL REPORT

MINISTRY OF POWER

21.02.2022

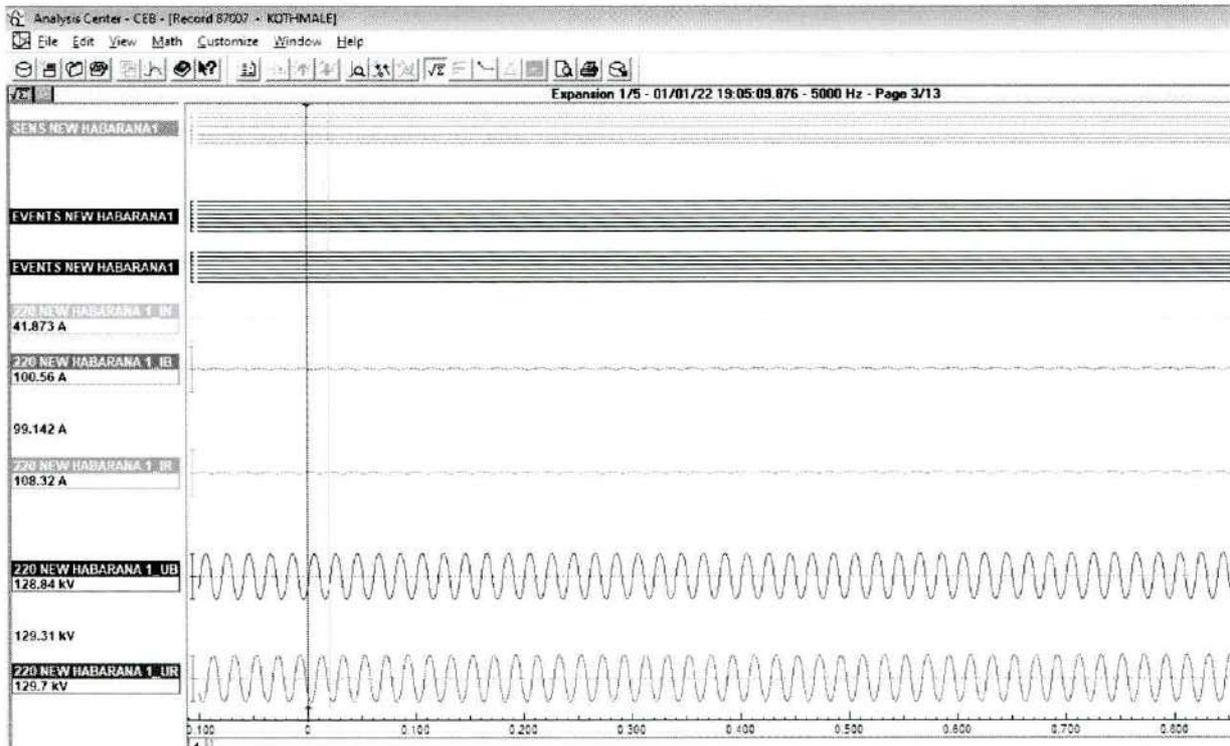
Qualitrol Ben 6000 Digital disturbance recorder at Kothmale PS was re calibrated by the Comcorp (Pvt) Ltd. on 2021-12-17, who are the local agent of the original equipment manufacturer. After the calibration it was identified the presence of substantial persisting zero sequence currents in transmission lines connected to Kothmale PS as seen in figure 01 and figure 02.

Figure 01: DDR at Kothmale PS – Analog waveforms of New Habarana line 01

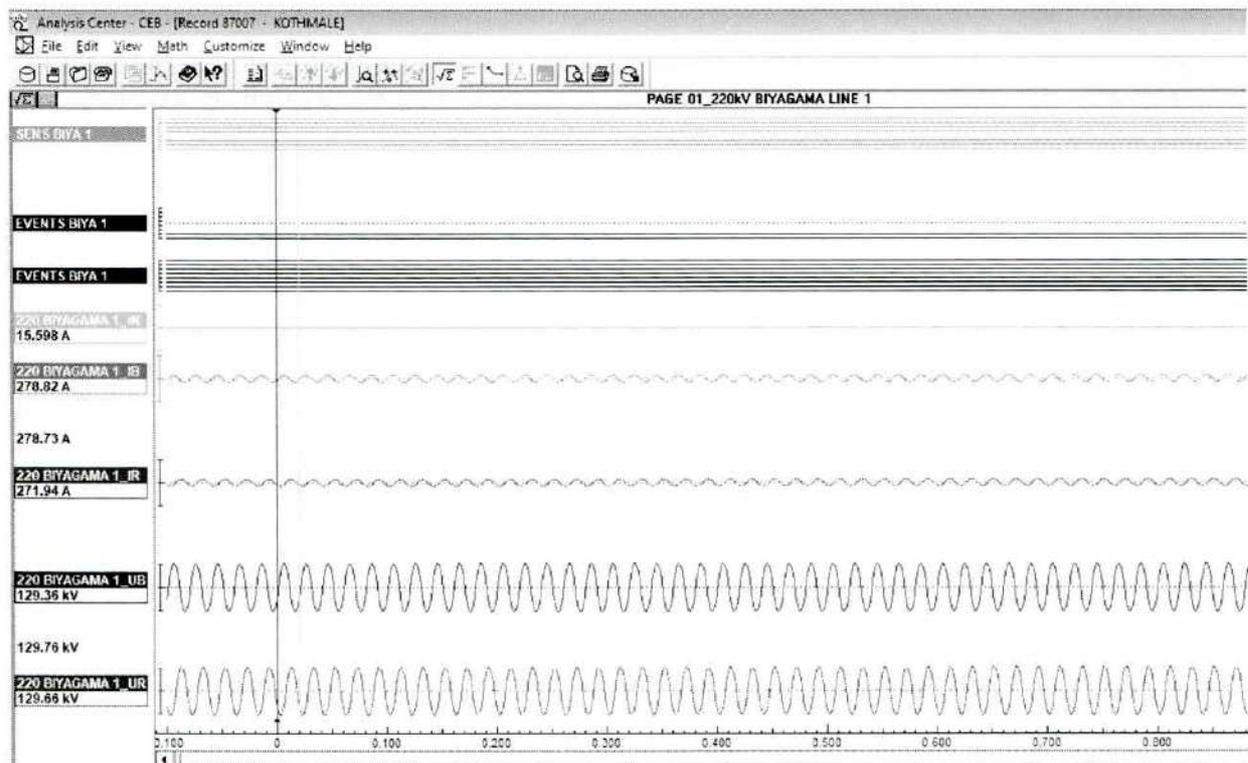
Figure 02: DDR at Kothmale PS – Analog waveforms of Biyagama line 01

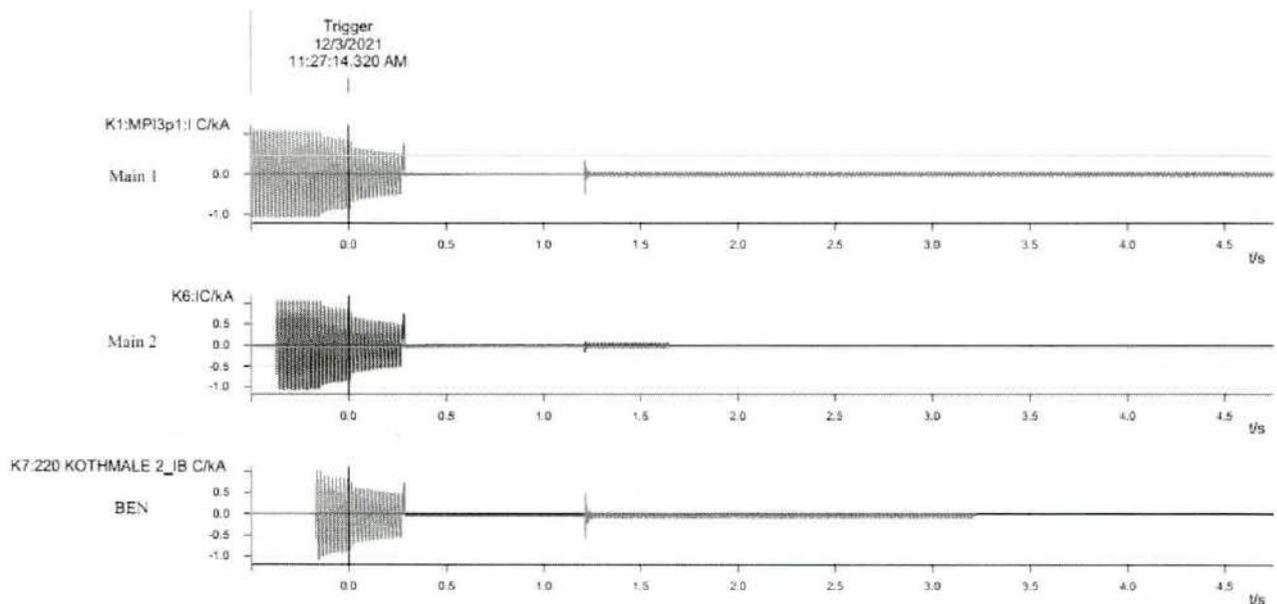
It is observed that the B phase to earth fault current of approximately 450A detected in Main 1, Main 2 relays and BEN DDR of Kothmale – Biyagama line 2. Main 1 relay is connected to Core 1 of current transformer while Main 2 and DDR are connected to core 2. Similar fault current waveforms were observed in all three devices.(figure 06) However it was observed that a similar fault current is not present in the fault records in Kothmale end. Additionally, a small zero sequence current could be observed in all connected 220kV bays at Biyagama GSS prior to the tripping of Kothmale line 02.

Figure 06: Current waveforms seen by Main 1 relay, Main 2 relay and DDR at Biyagama GSS – Kothmale line 2 B phase

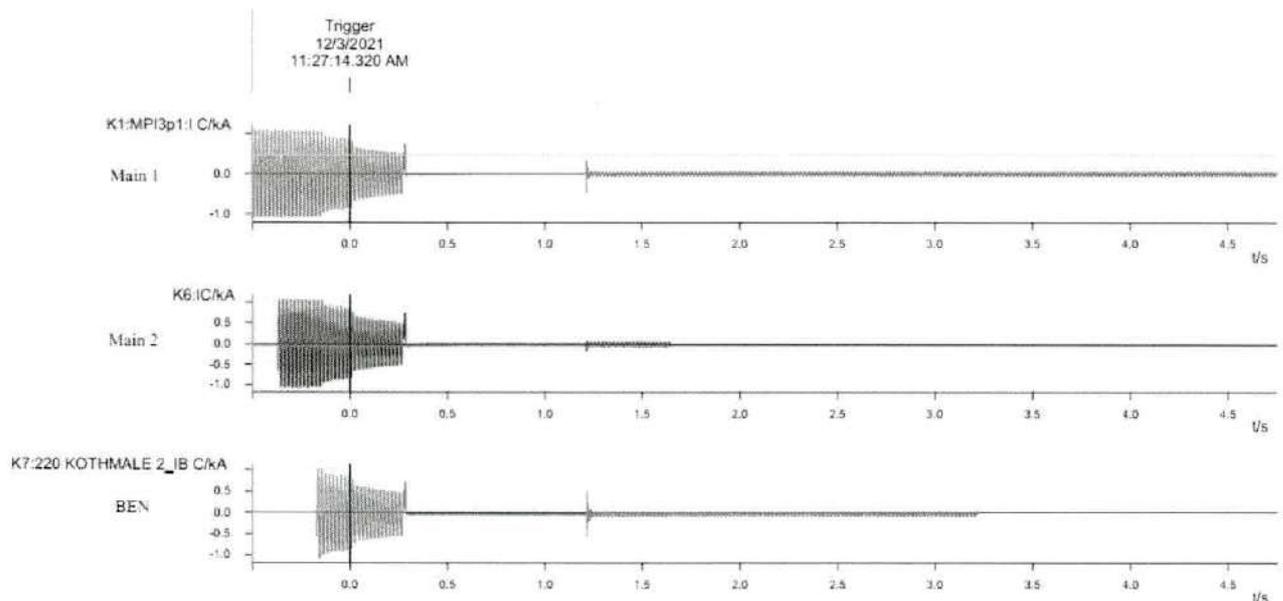
It is observed that the C phase to earth fault current of approximately 520A detected in Main 1, Main 2 relays and BEN DDR of Kothmale – Biyagama line 2. Main 1 relay is connected to Core 1 of current transformer while Main 2 and DDR are connected to core 2. Similar fault current waveforms were observed in all three devices (figure 06). Zero sequence current fed to the fault from Biyagama end is approximately 390A and a zero sequence current of 90A could be observed in the fault records in Kothmale end of Line 2. Additionally, it is observed that the summation of zero sequence currents observed in all connected 220kV bays at Biyagama GSS prior to the tripping of Kothmale line 02 equals the zero-sequence current flowing in Kothmale line 2. This zero-sequence current has been cleared with the tripping of phase C. Hence it is clear that there has been a primary fault in the line.

Figure 06: Current waveforms seen by Main 1 relay, Main 2 relay and DDR at Biyagama GSS – Kothmale line 2 B phase

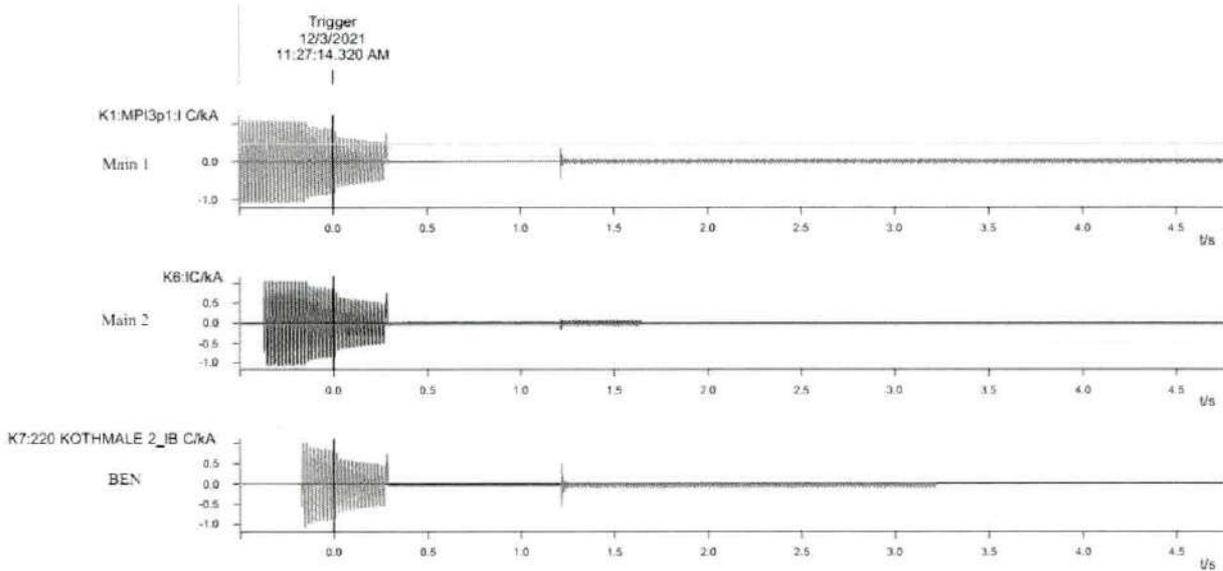
Kothmale – Biyagama line 2 has tripped due to the occurrence of C phase to Earth fault (magnitude 520 A) in transmission line and/or connected primary equipment i.e. CT, VT, Lightning Arrester etc. This fault current has been recorded in Main 1, Main 2 relays and the BEN6000 Digital disturbance recorder. The recorded waveforms from these equipment are shown below:

Figure 01: Current waveforms seen by Main 1 relay, Main 2 relay and DDR at Biyagama GSS – Kothmale line 2 B phase

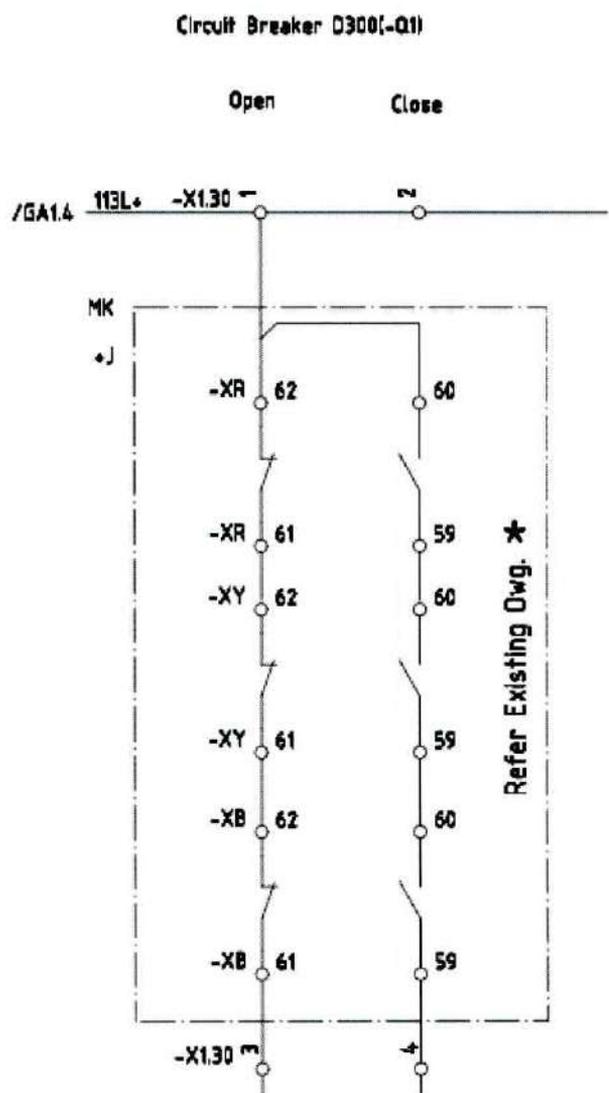
During the incident on 2021-12-03, phase C – Earth fault has occurred in Biyagama – Kothmale line 02 resulting in single pole tripping of Circuit Breaker. However the circuit breaker open status input signal has been incorrectly received as all 3 poles are open and since two phases are still conducting, end fault protection has operated and a direct inter trip has been sent to the Kothmale end resulting in permanent tripping of the circuit breaker at that end. As per the schematic drawings circuit breaker open status to busbar protection panel is taken from the control panel. A series of Normally Closed contacts are used to detect opening of all three phases in the Central cubicle box of the Circuit Breaker. (Ref. figure 01) According to the schematics, Circuit Breaker open status shall be received only when all three phases are open. However due to an error in field wiring Circuit Breaker status was received incorrectly to the control panel. This has been identified and rectified on 2021-12-26 (Kothmale line 01) and on 2022-01-02 (Kothmale Line 02) respectively.

Figure 02: Circuit Breaker open status taken to the control panel from the central cubicle box of the Circuit Breaker

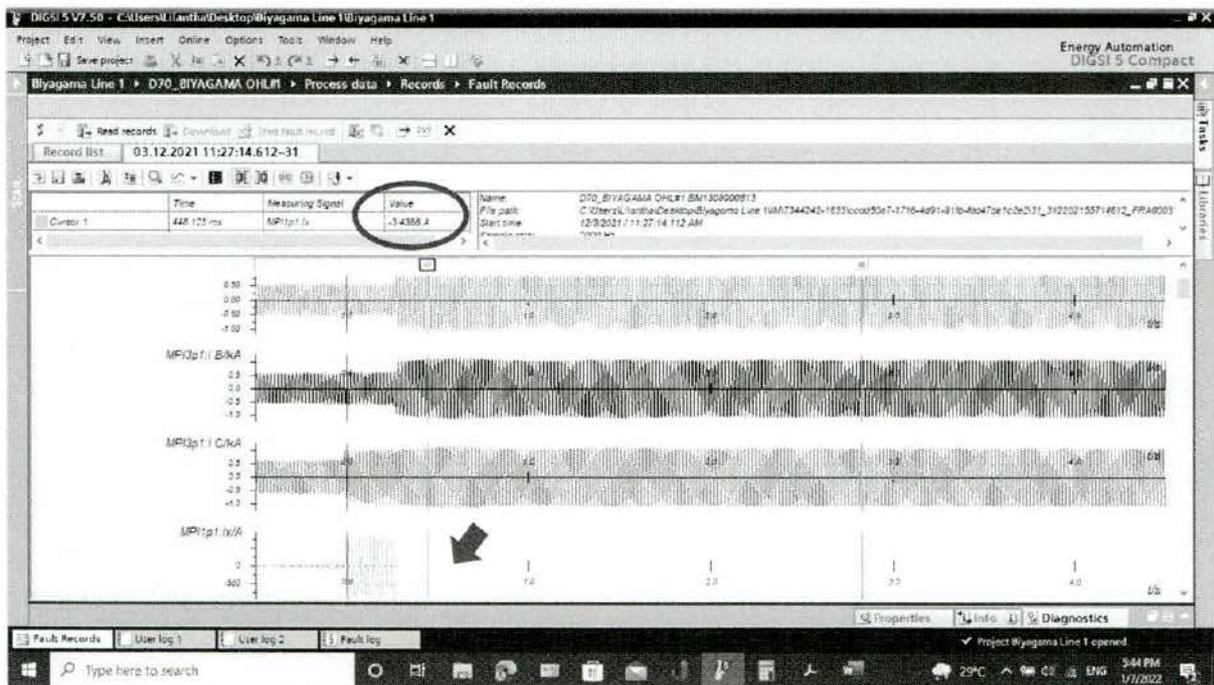
4. The CEB response on page 6 of the Annexure 05 mentions that ***“In the mutual line compensation wiring available in these two circuits, neutral of the parallel circuit is wired to the protection relay. Neutral current shown in Main 01 relay of Line 01 is the neutral current of the Line 02 which has tripped approx. in 288ms. This could have led to the above misleading statement”***. Figure 1 shows the screen shot of fault records of the SIEMENS 7SL87 protection relay of the Line 01 as recorded in the relay. We may be able to accept CEB’s explanation that the neutral current shown in Main 01 relay of Line 01 is the neutral current of Line 02, because it has become almost zero following Line 02 tripping.

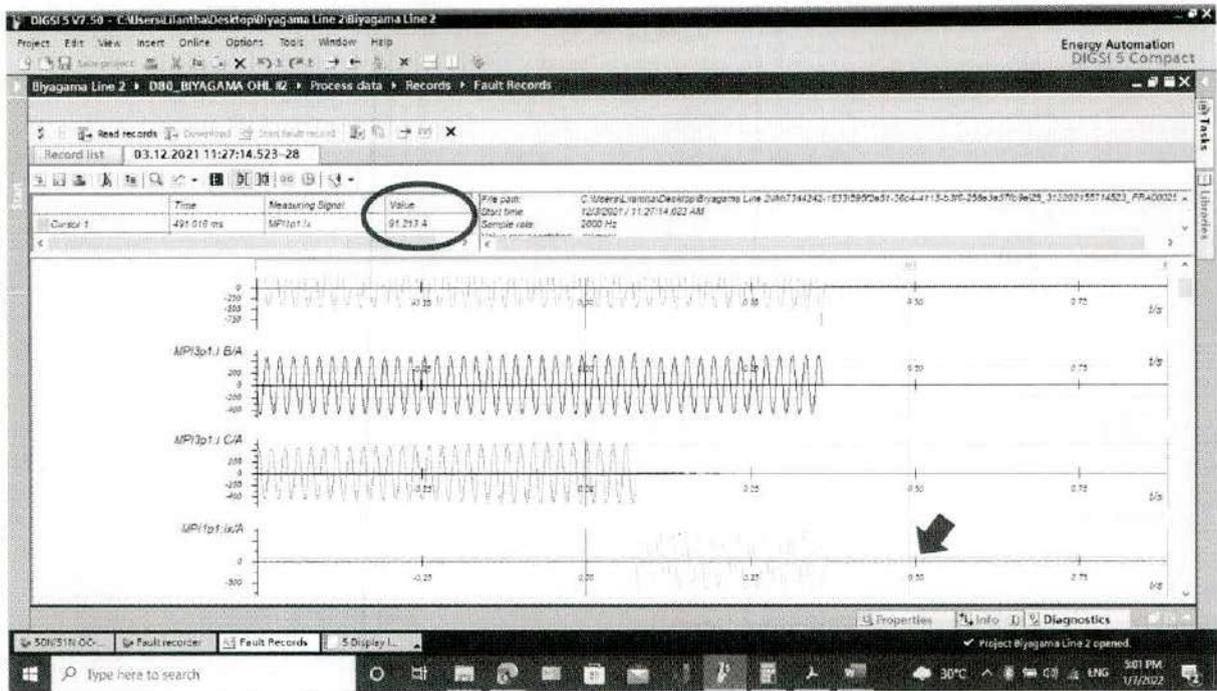
Figure 2 shows the screen shot of fault records of SIEMENS 7SL87 relay as recorded in the protection relay of the Line 02. According to the above-mentioned wiring arrangement explained in the CEB response, the neutral current (bottom waveform) should be the neutral current of Line 01. We note that its peak value following Line 02 tripping is 91.213 A (rms value 64.5 A). According to the explanations given in the CEB response, the setting is 80 A and the pickup current is 10% higher than the setting (88 A) and dropout current is 10% less than setting (72 A). It is noted that the neutral current drops to 64.5 A (which is less than 72A), after 288 ms following the Line 02 tripping. Hence, the Committee finds no reason for the Earth Fault protection to operate as late as 22.33 seconds after, when the current has decreased below the dropout threshold in 288 ms. CEB should explain this issue giving reasons/justifications.

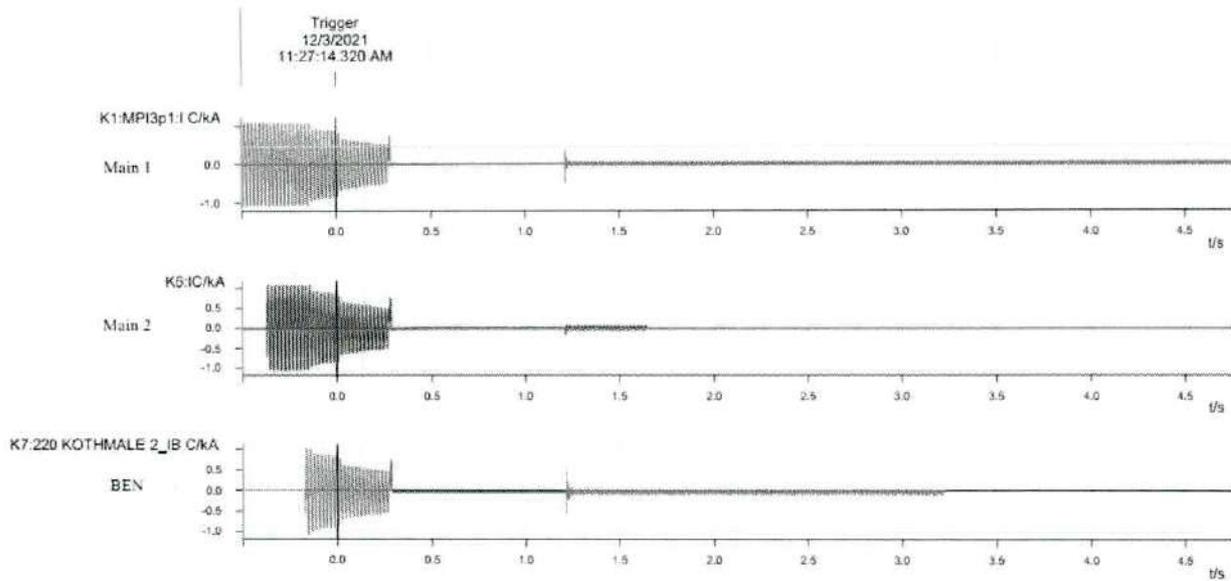
Kothmale – Biyagama line 2 has tripped due to the occurrence of C phase (ABC notation) to Earth fault (Differential current of 521 A) in the primary side. The physical arrangement of primary equipment in Kothmale Lines at Biyagama GSS is shown in Annexure I.1.viz. Transmission line, Circuit Breakers, Current Transformers, Line Isolator, Voltage Transformer, Lightning Arrester. This fault current has been recorded in Main 1, Main 2 relays and the BEN6000 Digital disturbance recorder. The recorded waveforms from this equipment are shown below:

Figure 01: Current waveforms seen by Main 1 relay, Main 2 relay and DDR at Biyagama GSS – Kothmale line 2 C phase (In ABC notation)

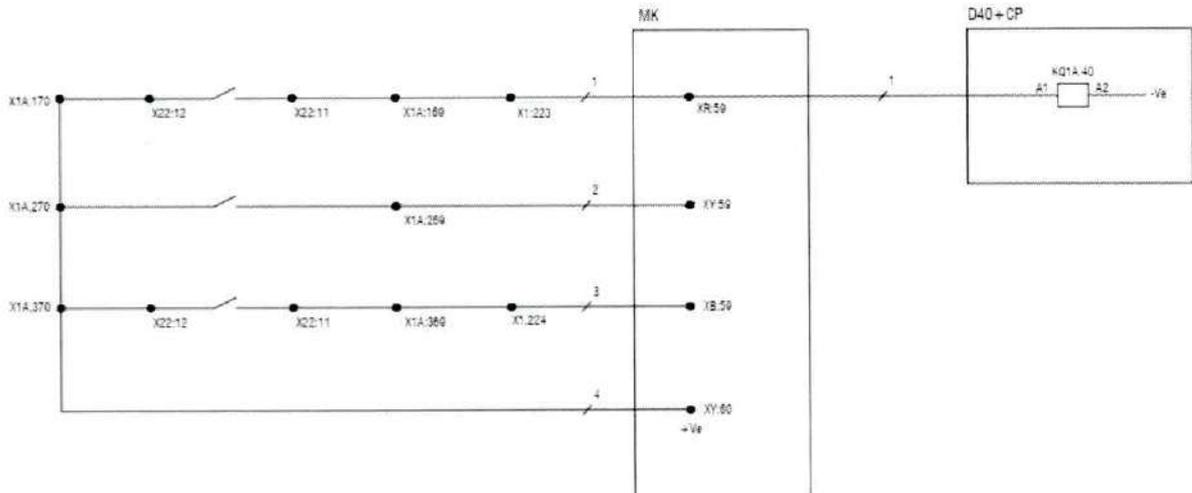
As per the existing wiring only CB-R phase status feedback is receiving to the Control Panel and other two-phase statuses were disregarded.

Figure 05: Existing CB close feedback to C&P relays of Kothmale line 1

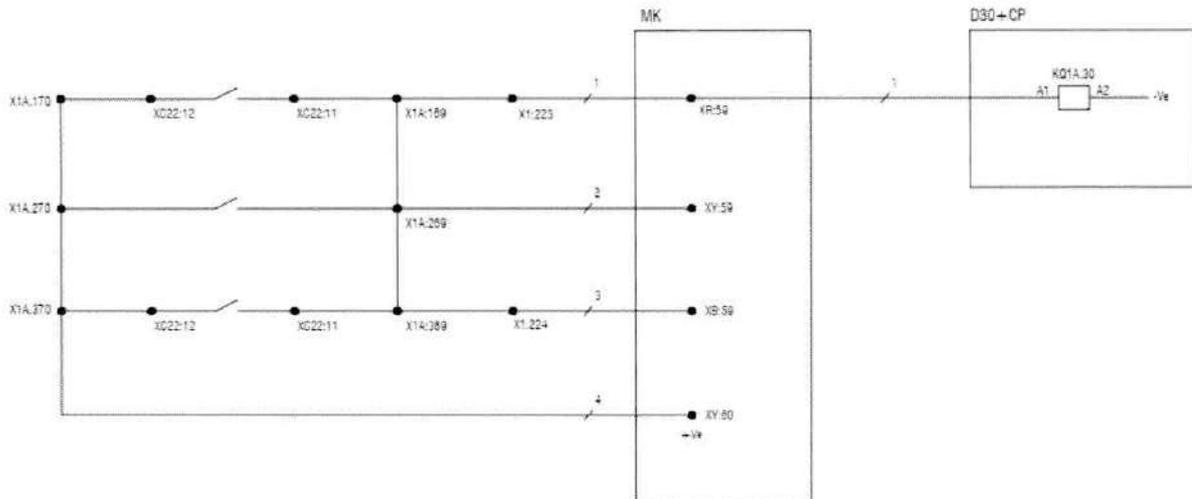
As per the existing wiring paralleling of NC (Normally Closed) contacts were used to give the opening of all three phases to the Busbar Protection relay. Please refer below drawing. This scheme is incorrect and should be serially connected as above Figure 04.

Figure 06: Existing CB close feedback to C&P relays of Kothmale line 2

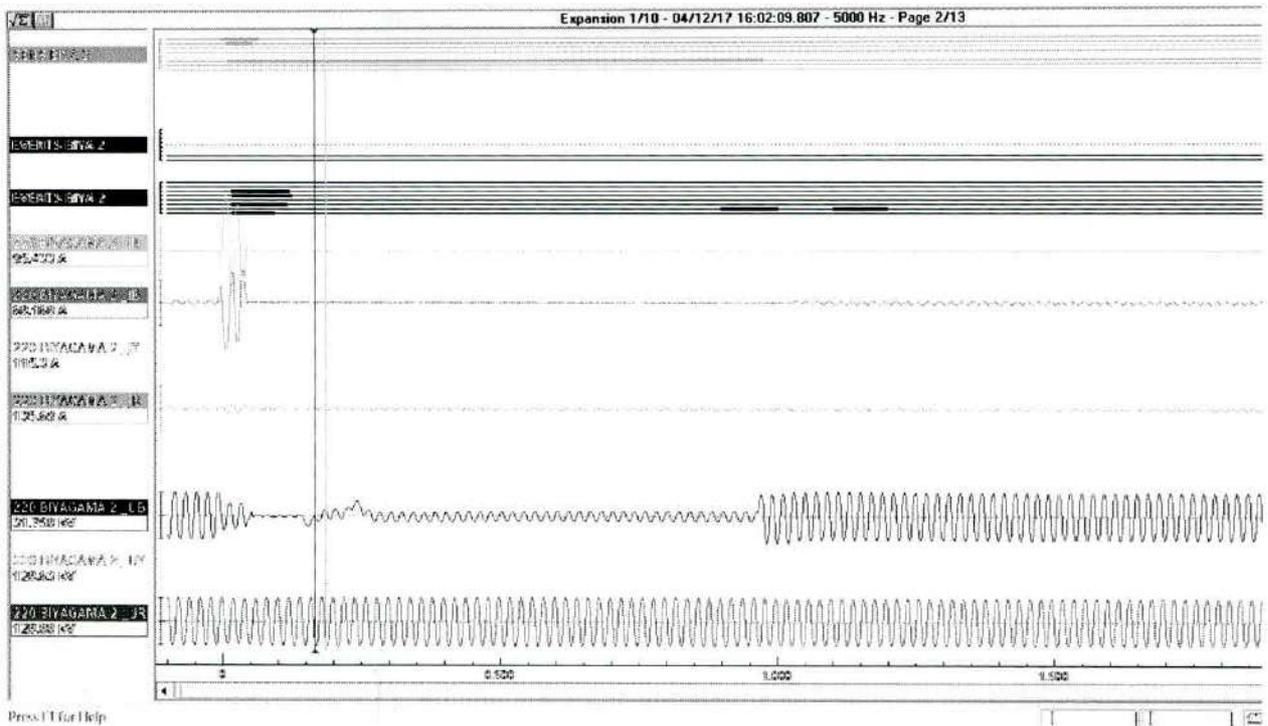
During this instance B phase has tripped from both ends and it is observed that the currents in the healthy phases are in the range of 100A -150 A and hence even if the circuit breaker status is open it does not exceed the threshold current required to trigger end fault protection as seen in the DDR record in figure 10.

Figure 10: Ben 6000 DDR record of Biyagama line 2 at Kothmale PS at 16:02 on 2017-04-12

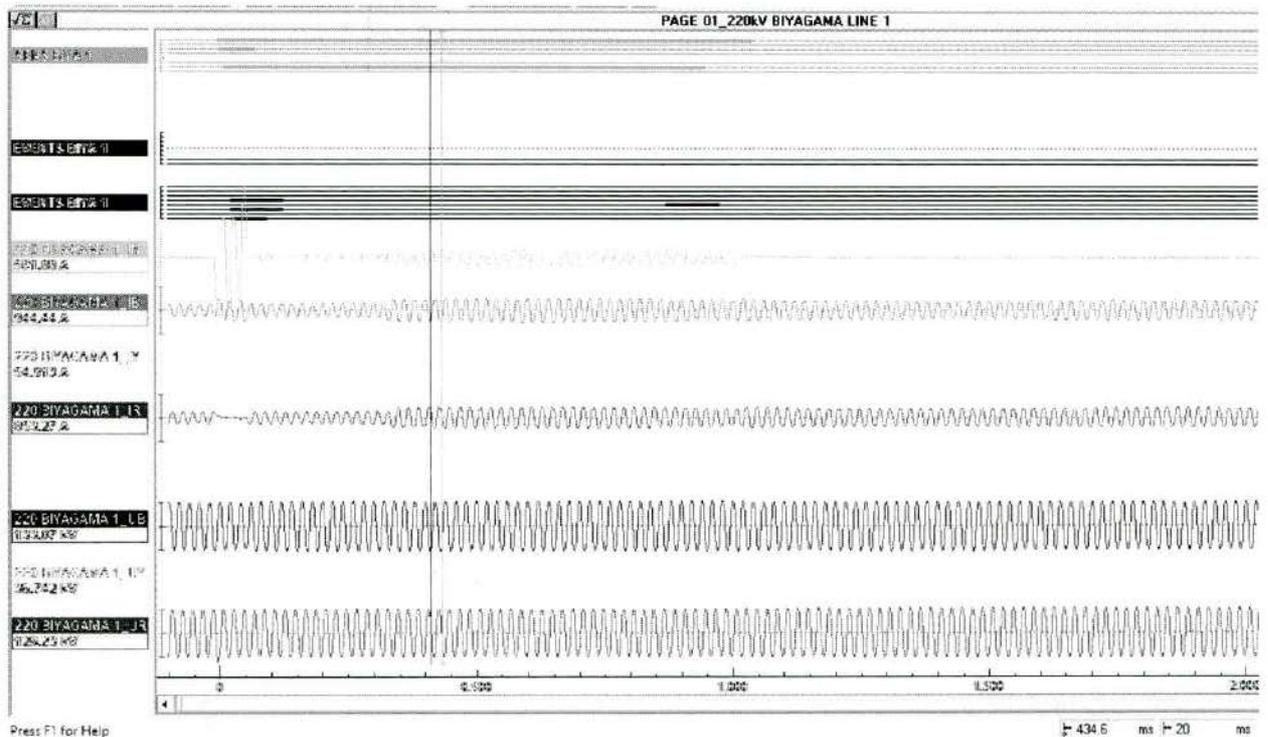
During this instance Y phase of line 1 has tripped and it is observed that the currents in the healthy phases are increasing up to 900A (figure 11) yet end fault protection has not picked up since the circuit breaker status is being received as Close as per the wiring.

Figure 11: Ben 6000 DDR record of Biyagama line 1 at Kothmale PS at 18:49 on 2021-05-11
