**FINDINGS OF THE COMMITTEE APPOINTED TO
INVESTIGATE POWER SYSTEM FAILURES ON
NOVEMBER 29, 2021 AND DECEMBER 03, 2021**

**MINISTRY OF POWER
SRI LANKA**

**Final Report
February 21, 2022**

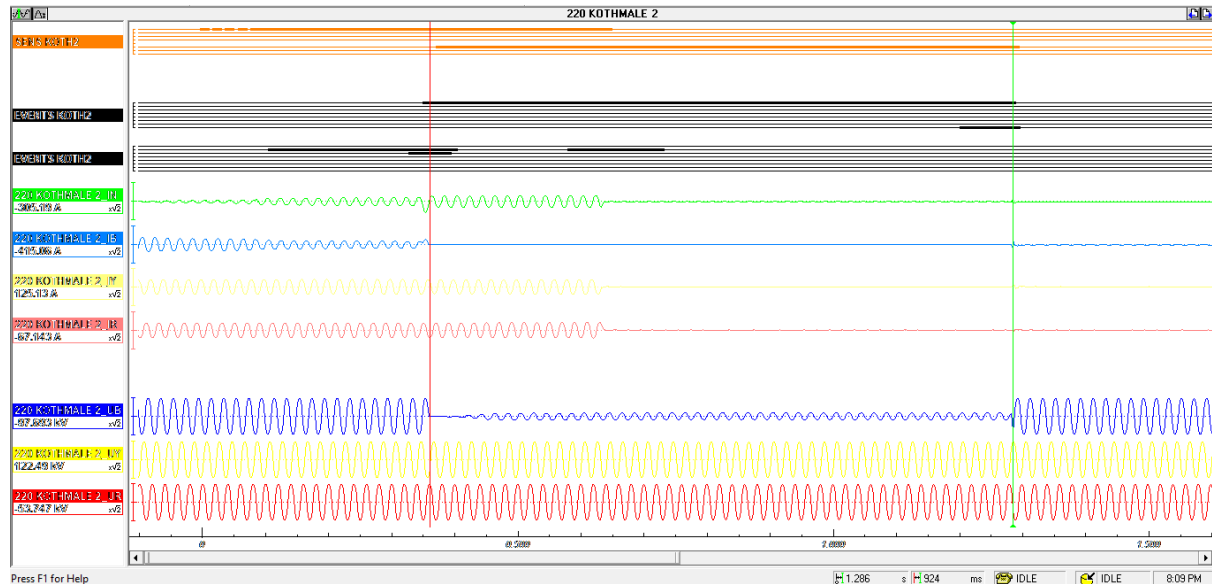
Figure 2.1 – DFR Records of Circuit 2 of Kotmale- Biyagama 220 kV Transmission Line at Biyagama End on 3rd December 2021 at 11:27:14

It appears that the failure has started with a fault on phase B (in RYB notation) of circuit 2 of this transmission line. According to the DFR (BEN6000; sampling frequency 5 kHz) reports at the Biyagama GS, on December 03, 2021 at 11:27:14, phase B current of circuit 2 has gradually decreased from approximately 740 A to 375 A while the neutral current has increased correspondingly from 88 A to 440 A. DFR Records also indicate that the differential protection relay at the Kotmale Substation of circuit 2 has operated and tripped phase B from both Biyagama and Kotmale ends, effectively isolating any fault that may have caused the initial high neutral current.

Records obtained from the BEN6000 DFR at Biyagama GS indicate that phase B circuit breaker (CB) of circuit 2 had initiated the auto-reclosure sequence. Following the opening of CB of phase B, the neutral current of circuit 2 had increased further to 600 A. This high neutral current could have been caused by the imbalance introduced by opening of phase B. It had continued to increase gradually up to 629 A, at which point all three phases of circuit 2 had tripped from the Kotmale end causing the CB lockout. This tripping had been caused by the activation of end-fault protection of Biyagama busbar 2, approximately 288 ms after the initial opening of CB of phase B. After this event, the CB of phase B at Biyagama end had reclosed, signifying the continuation and completion of the auto-reclosure sequence (after 924 ms from

its initial opening). Records of BEN6000 DFR at Biyagama GS for the above scenario are reproduced in Figure 2.1.

The phase B current and the corresponding neutral currents are consistent with those associated with a high impedance earth fault on phase B. The CEB has taken the position in its reports to the Committee that it was a primary side failure that caused this high neutral current as opposed to any other cause (such as faulty secondary equipment), in view of the identical current waveforms observed in the CT secondaries connected to the Main 1 relay (SIEMENS SIPROTEC 5 7SL87), Main 2 relay (Schneider Easergy MiCOM P546) and the DFR (BEN6000). CEB informed the Committee further that the primary side failure had been non-persistent since this circuit was re-energized successfully during the system restoration after the total failure.

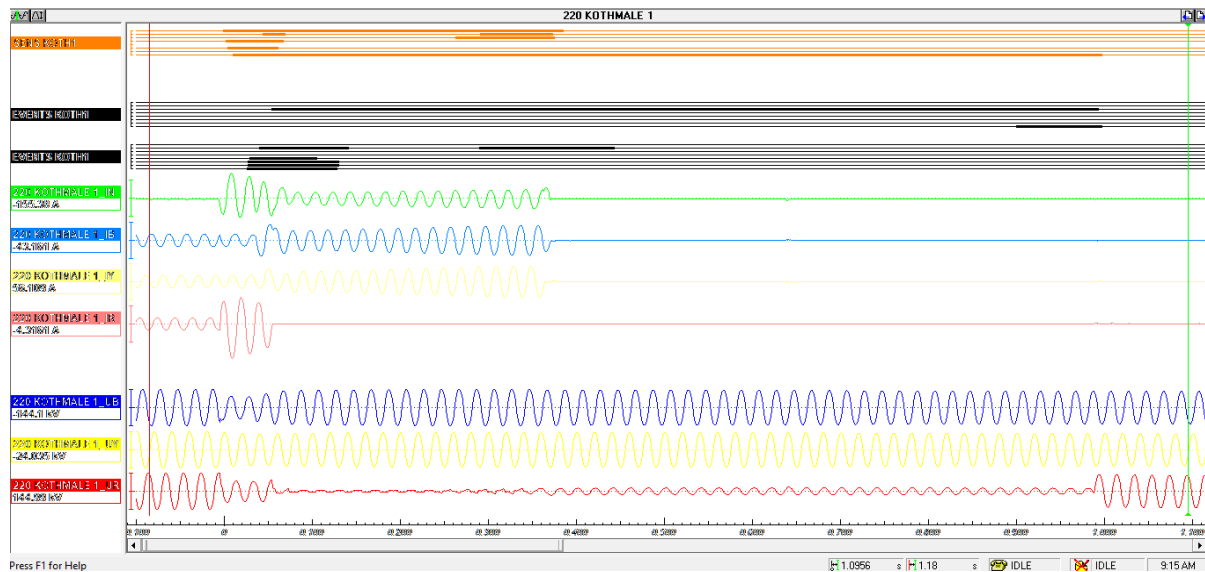
Figure 2.4 - DFR Records of Circuit 1 of Biyagama - Kotmale 220 kV Transmission Line at Biyagama End on 29th November 2021 at 19:25:07

It can be seen that a similar tripping signal had been issued on November 29, 2021 (4 days before the incident on the December 03, 2021), highlighted in blue in Figure 2.3, following what is suspected to be a single-line-to-ground fault associated with phase R of circuit 1 of Kotmale-Biyagama 220 kV transmission line. In this instance, phase R had reclosed after 934 ms, by which time all three phases of this circuit had been tripped from the Kotmale end by the activation of end-fault protection of busbar 1 of the Biyagama GS (317 ms after initial CB opening of phase R). It has also caused lockout of the CBs, thus preventing the completion of auto-reclosure. The corresponding DFR records are shown in Figure 2.4, which clearly show the currents in all phases becoming zero before the CB of phase B recloses (the waveform at the bottom). In this case too, both circuits of the Kotmale-Biyagama 220 kV transmission line would have returned to normal service if the end-fault protection did not operate erroneously. It is unfortunate that the CEB's protection engineers had not commenced an immediate investigation into this spurious activation of end-fault protection on November 29, 2021. We can state with high degree of confidence that the total failure on December 03, 2021 could have been avoided, had such an investigation on the partial failure on November 29, 2021 been carried out and immediate remedial measures taken.

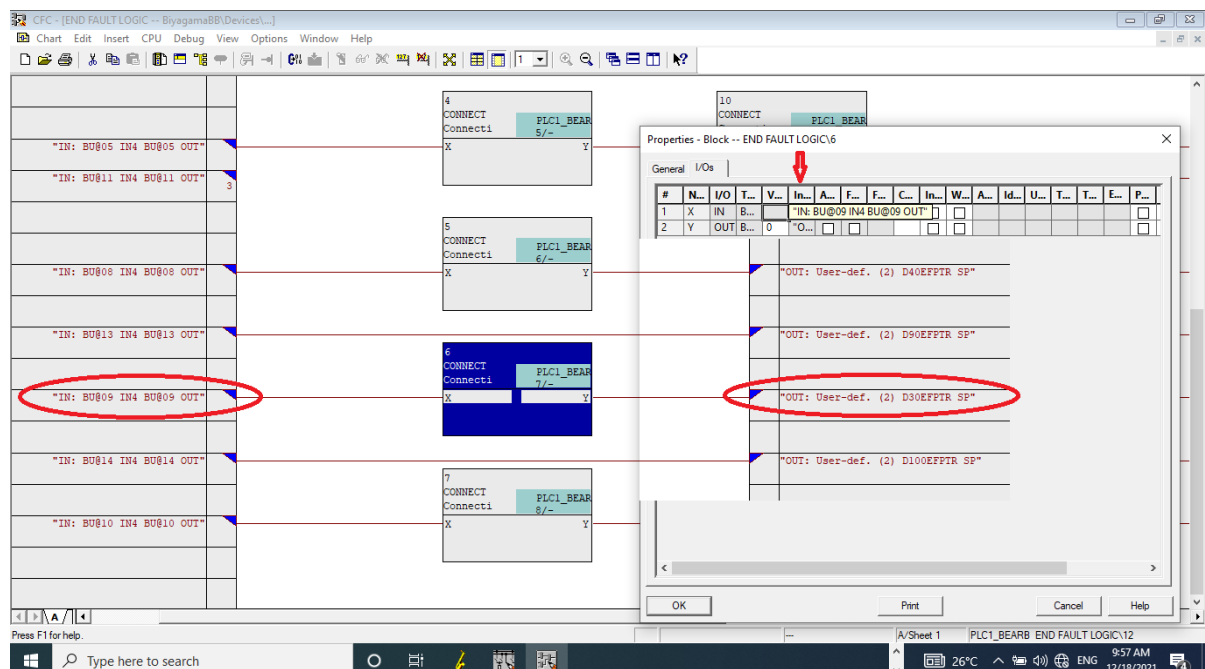
Figure 2.5 – End-Fault Function Implementation in the SIEMENS 7SS522 Relay

The Committee studied the end-fault logic implemented in SIEMENS 7SS522 relay from the records in the relay accessed using DIGSI V4.93 software. Figure 2.5 shows the screenshot highlighting the output generated by the D30EFPTR using the relay function block. The properties of the function block reveal that only the neutral current (I_N) is taken as the input. Accordingly, when I_N exceeds a certain threshold, the end-fault tripping is activated.

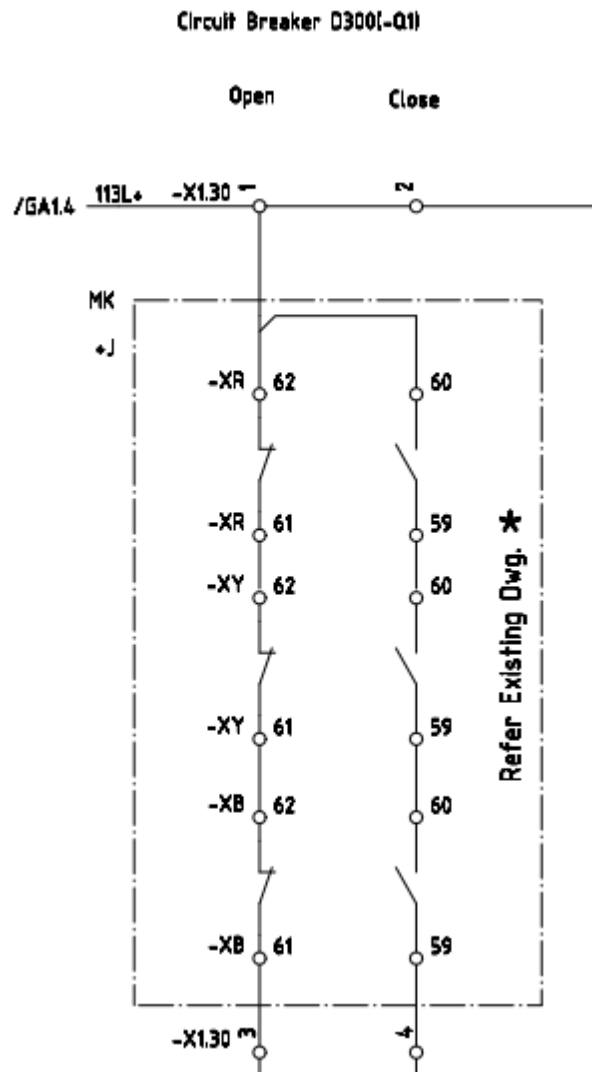
Figure 2.7 – As-built Circuit of Auxiliary Contacts of End-Fault Protection Supplied by ASEA in 1986

As-built circuit diagram of circuits 1 and 2 of Kotmale–Biyagama 220 kV transmission line supplied in 1986 by ASEA of Sweden (reproduced here from the original drawings) reveals that the CB positions of the three phases are collected using three series connected Normally-Closed (NC) auxiliary contacts as shown in Figure 2.7. According to the above implementation, the end-fault protection can operate when all 3 poles are open, all 3 NC auxiliary contacts are closed, and no other protection has operated already.

Therefore, the conditions for the operation of the end-fault protection had not been satisfied. Yet, end-fault protection on circuit 2 at Biyagama GS had been activated, and a command had been issued to disconnect the circuit completely and to lockout the CB at the Kotmale end.

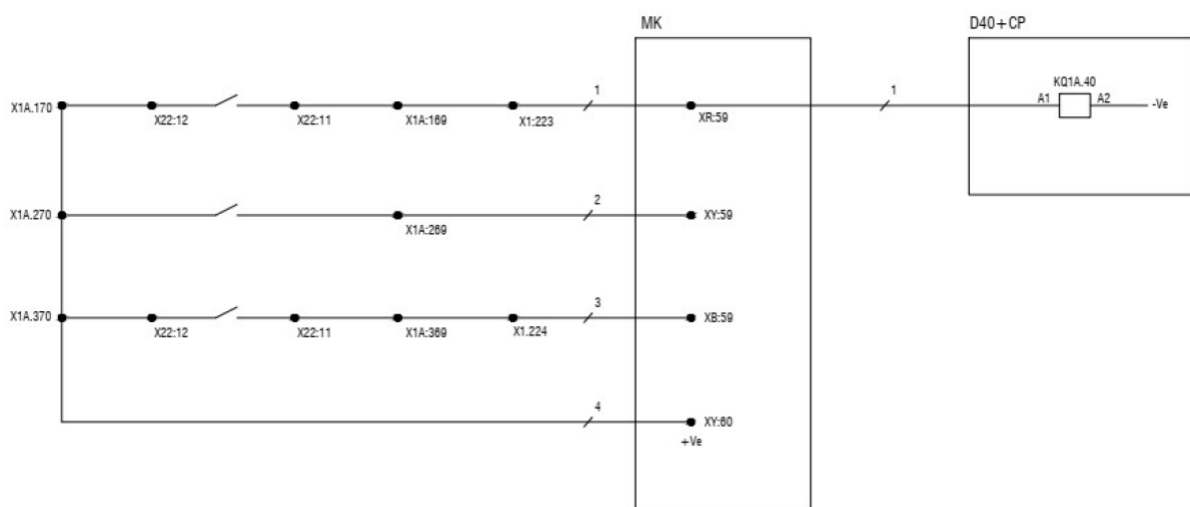
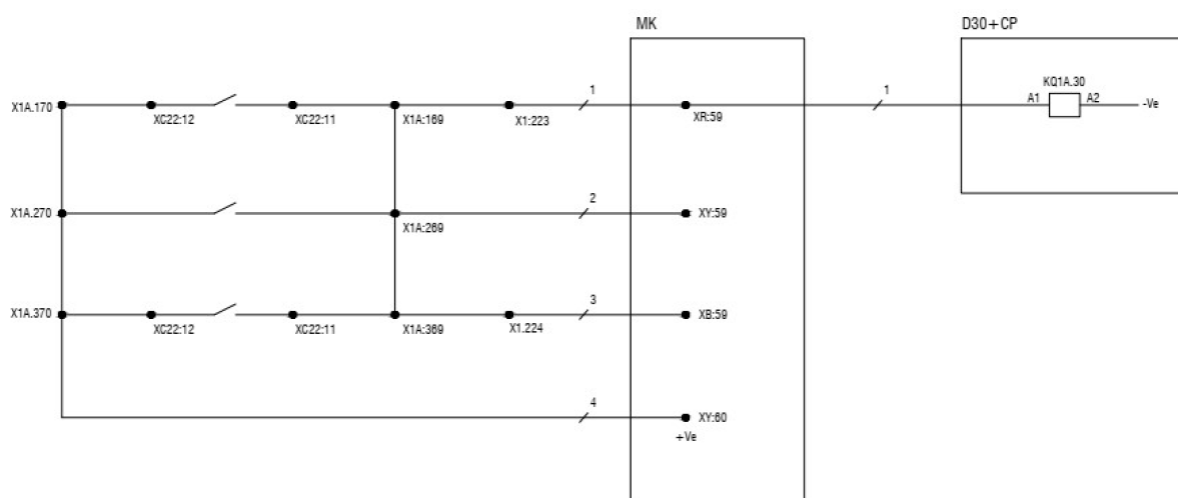
protection on November 29, 2021 and on the December 03, 2021 (after this matter was raised by the Committee), they had found the field wiring associated with the end-fault protection relay of busbar 1 and busbar 2 at Biyagama GS were as shown in Figure 2.8 and Figure 2.9 respectively. These wiring arrangements are markedly different to the original as-built drawings provided by ASEA in 1986. Further, CEB in its report to the Committee had attributed the alleged changes in the field wiring of the end-fault protection to a mistake made during the replacement of the CBs at Biyagama GS in circuits 1 and 2 of Kotmale–Biyagama 220 kV transmission line in early 2015.

The Committee notes significant differences between the original as-built wiring (Figure 2.7) and the purported schematic diagrams CEB has presented to the Committee (Figure 2.8 and Figure 2.9). These discrepancies are enumerated below:

- (i) Original wiring is based on NC auxiliary contacts which are closed when the corresponding CBs are open and vice versa, whereas Figure 2.8 and Figure 2.9 show Normally-Open (NO) auxiliary contacts.

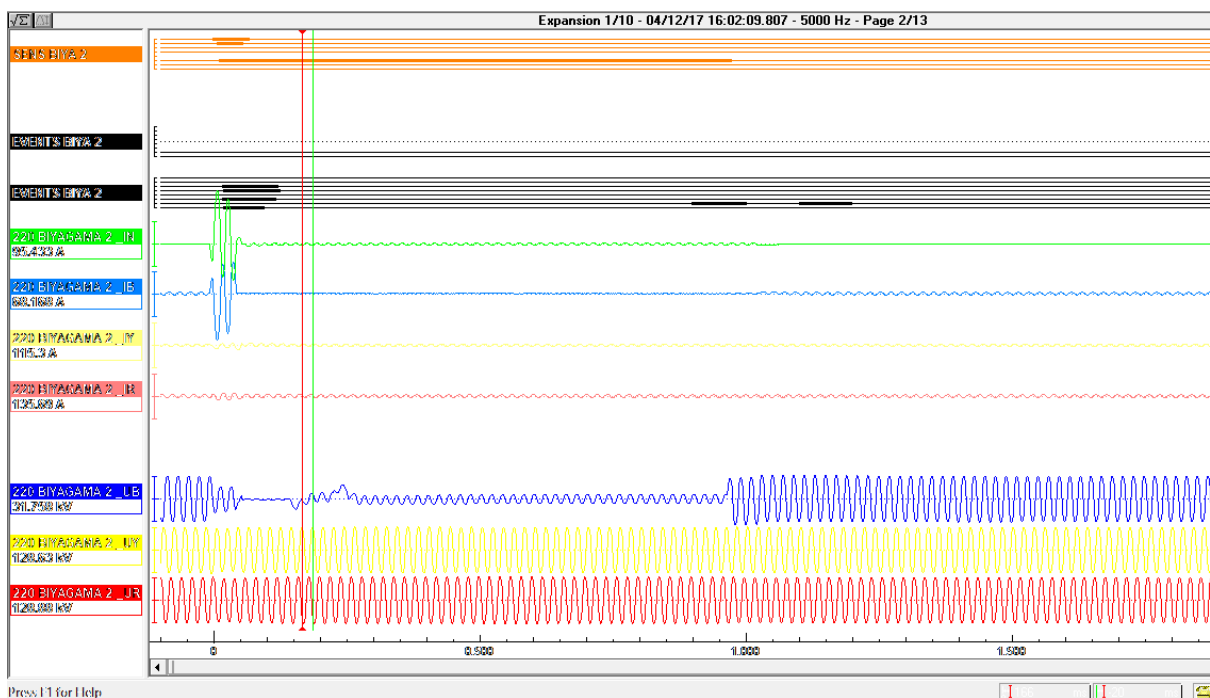
Figure 2.11 – DFR Record of Event in Circuit 1 of Kotmale-Biyagama 220 kV Transmission Line at 16:02 on April 12, 2017

Example 2: The end-fault protection did not operate in circuit 2 of Kotmale-Biyagama 220 kV transmission line at 16:02 on April 12, 2017 following a phase B to ground fault, where the currents in the healthy phases had been around 100-150 A, i.e., below 500 A. The corresponding record on the DFR is shown in Figure 2.11.

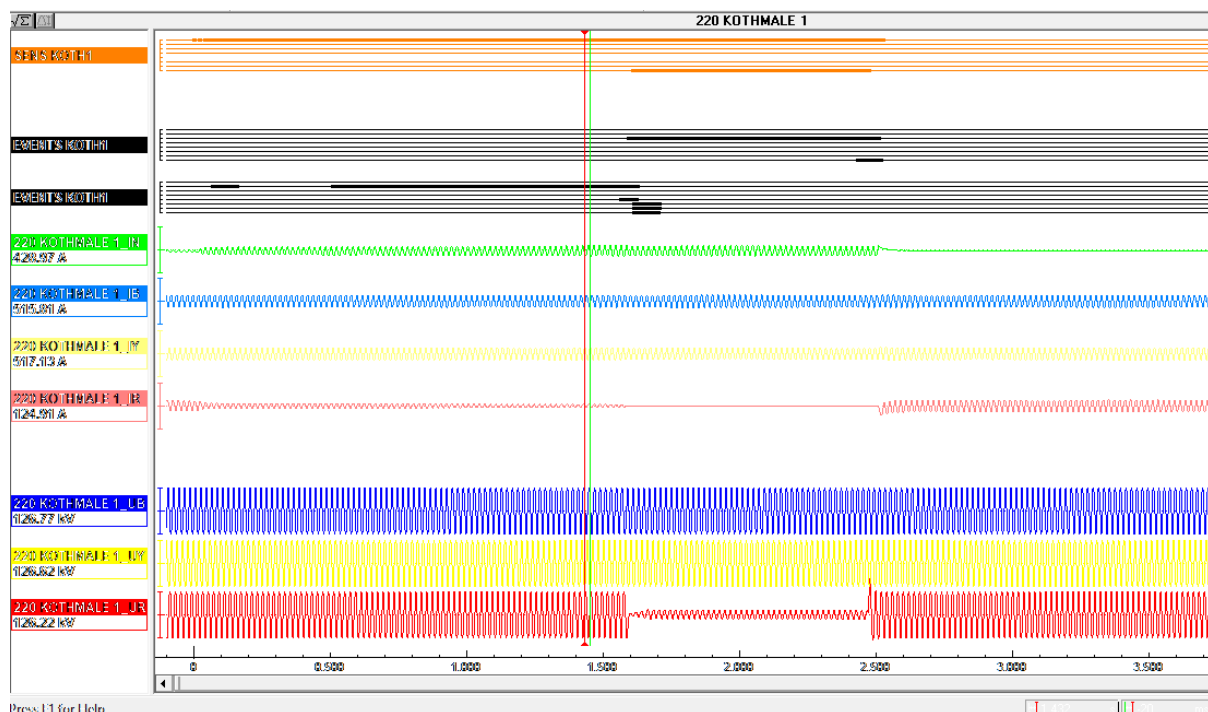
Figure 2.12 – DFR Record on Event in Circuit 1 of Kotmale-Biyagama 220 kV Transmission Line at 11:38 on the 18th October 2019

Further, the report submitted by the CEB shows a case that resembles a high impedance earth fault in phase R of circuit 1 of Kotmale-Biyagama 220 kV transmission line that occurred at 11:38 on October 18, 2019, where the phase R (according to the field wiring circuit diagram in Figure 2.8 presented to the Committee; this is the only phase where the CB position is actively considered for the end-fault protection operation) protection had isolated the fault for a while and currents in the healthy phases were above 500 A, but the end-fault protection had not operated. The corresponding record on the DFR is shown in Figure 2.12. This latter observation further confirms that the healthy phase currents to be greater than 500 A is not a necessary condition for the operation of the end-fault protection.

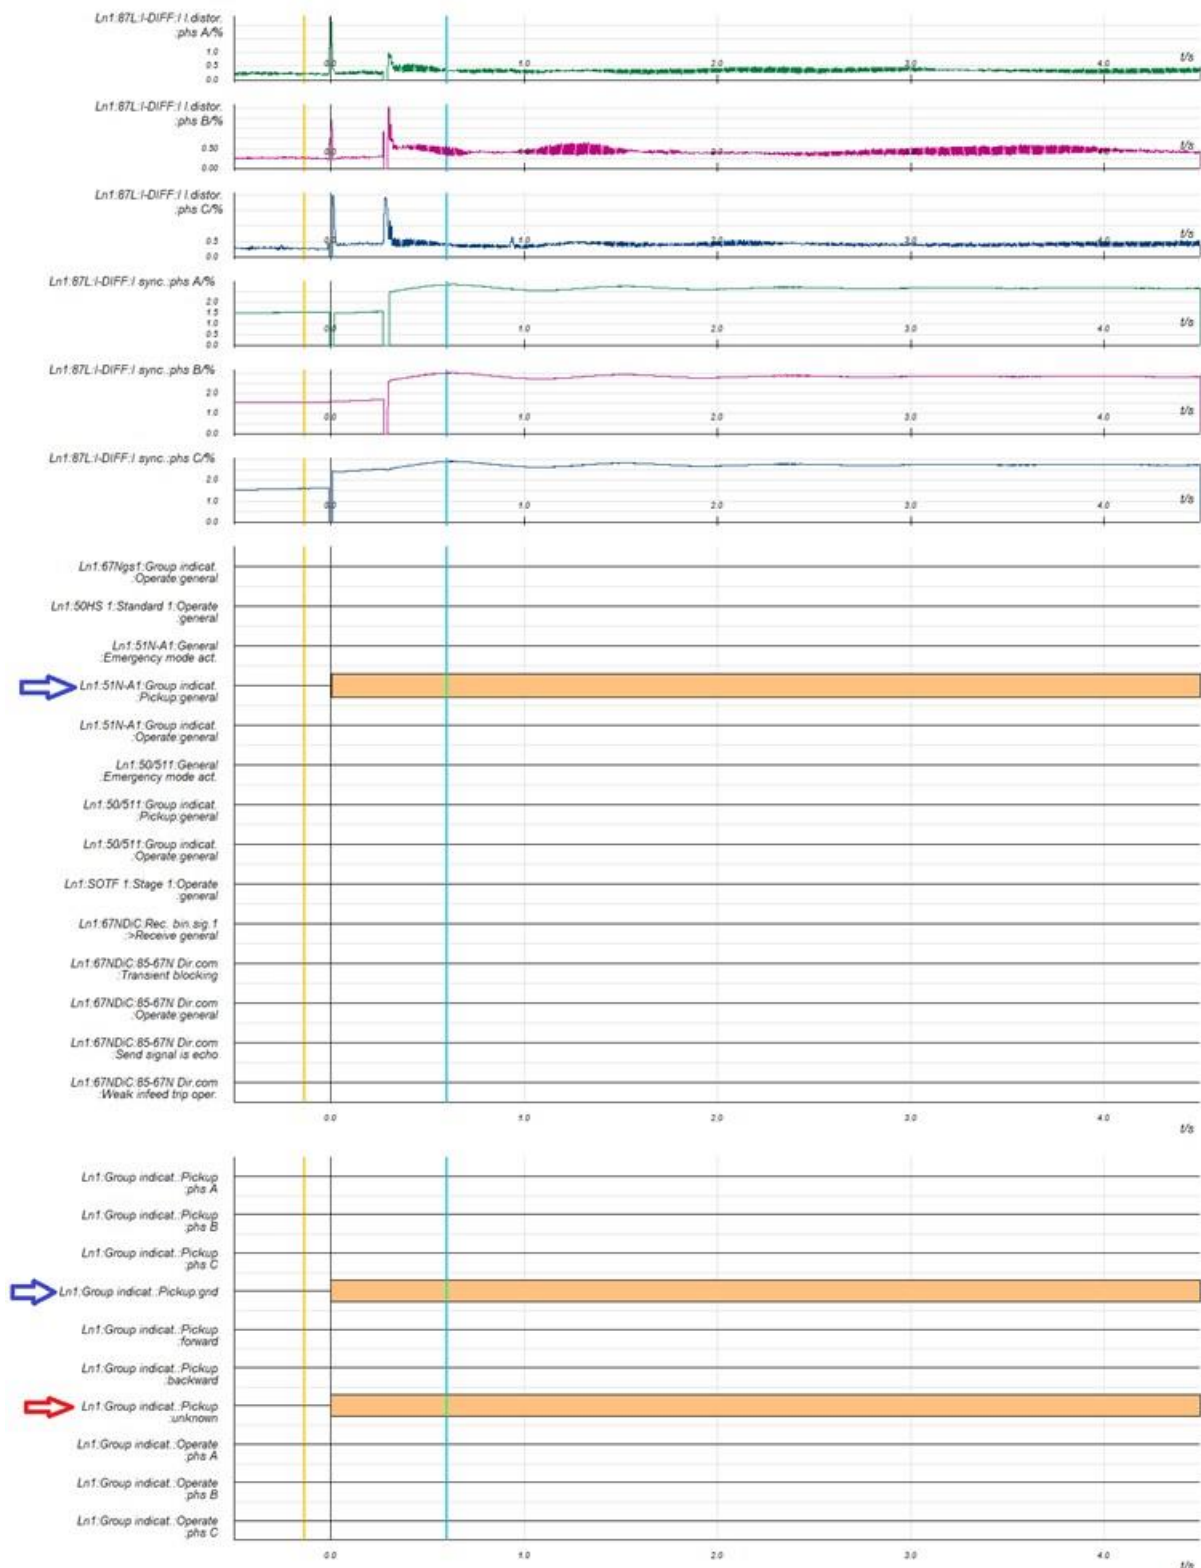
Figure 2.21 - Fault Trigger Signals on Circuit 1 of Kotmale- Biyagama 220 kV Transmission Line Obtained from SIEMENS 7SL87 relay at Kotmale Substation

Figure 2.21 shows the fault trigger signals of the relay SIEMENS 7SL87 of circuit 1 of Kotmale-Biyagama 220 kV transmission line located at Kotmale substation. The neutral current is picked up by the earth-fault channel as seen towards the bottom in the waveform diagram as

“Ln1:51N-A1:Group indicat:Pickup:general” (marked in blue colour), “Ln1: Group indicat:Pickup:gnd” (marked in blue colour) as well as “Ln1: Group indicat:Pickup:unknown” (marked in red colour).

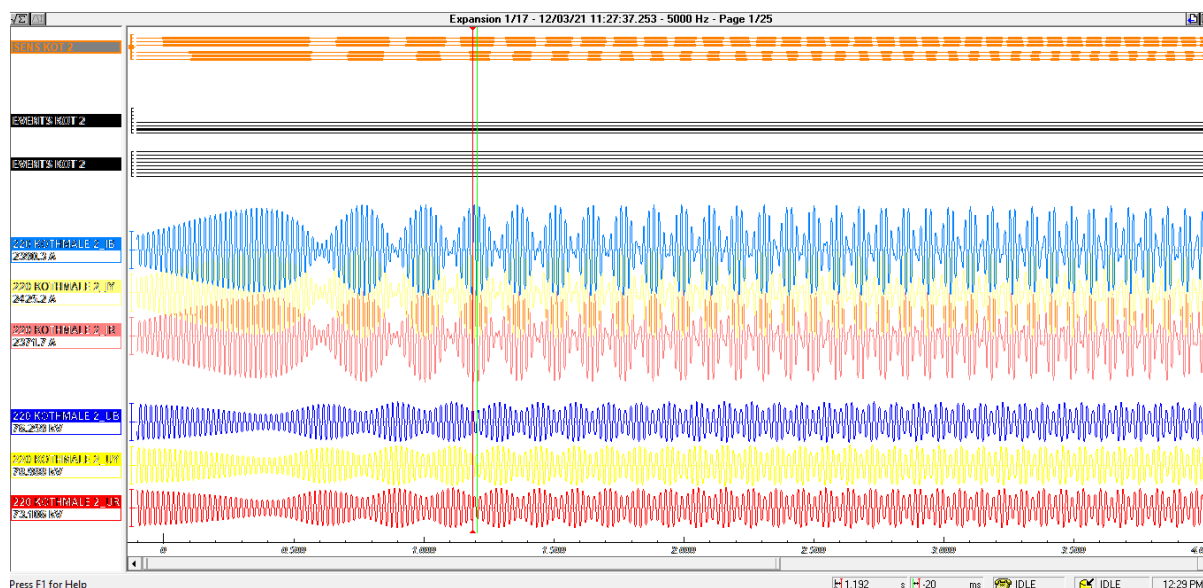
Figure 2.24 - DFR record of Circuit 2 of Kotmale-New Anuradhapura 220 kV Transmission Line at New Anuradhapura GS

In Figure 2.24, it can be seen that voltage and current amplitudes oscillate so that the current varies in an envelope of 550 A to 2,400 A and the corresponding voltage fluctuation in an envelope of 129 kV to 75 kV. This 2,400 A and 75 kV combination crosses the overcurrent limit and the under-voltage limit of the circuit respectively, as seen in the DFR records. During this time, the overcurrent protection **Line 1:50/51 OC-3ph 1p 1:Inverse-T 1** has picked up 103 instances and another 20 instances with a gap of 4.56 s and circuit has been eventually tripped by the operation of the Zone 1 distance protection **Line 1:21 Distance prot. 1:Z 1** from New Anuradhapura GS.
