**Response of CEB to the Final Report of the
committee appointed by the Ministry of
Power to investigate power system failures
on November 29, 2021 and December 03,
2021**

25 March 2022

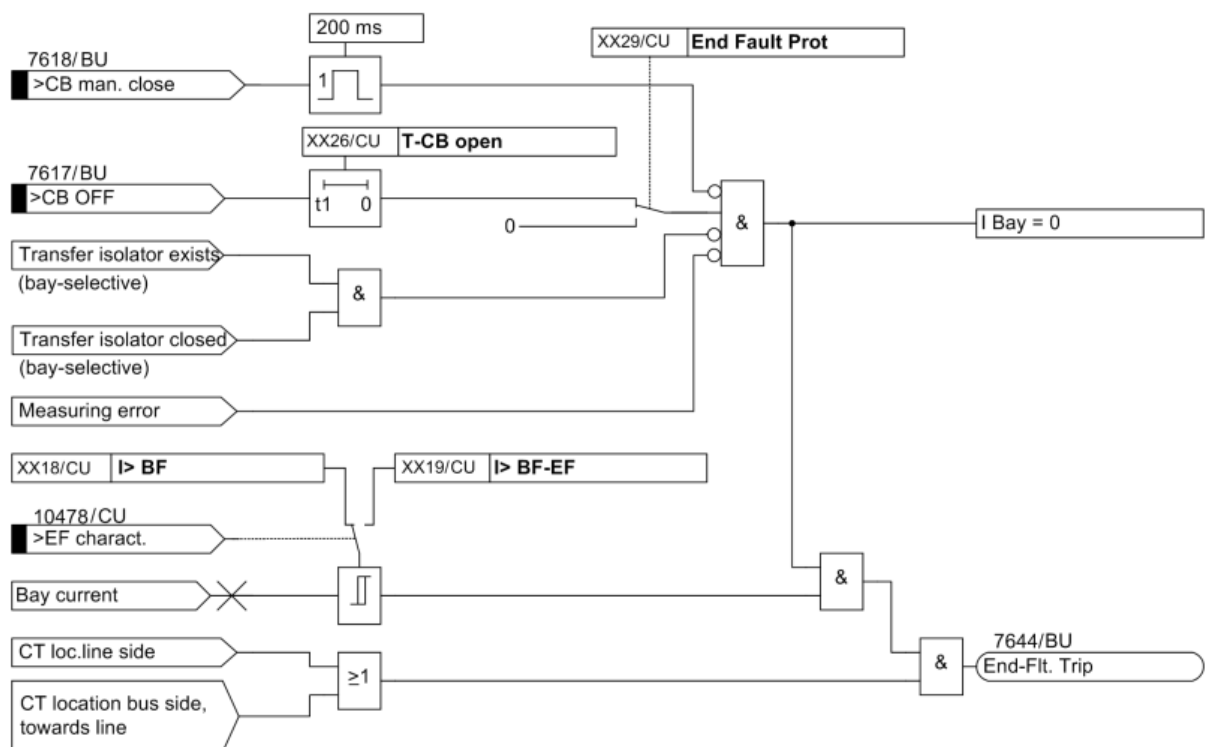
As per the below logic diagram, the end fault protection of the SIEMENS 7SS52 relay uses “Bay Current” value for the operation of the end fault protection. It uses the current value of “I>BF” setting as the threshold value for the end fault protection, which is 500 A in this case. Further, under the section “5.3.2 Setting Notes” related to the “Circuit Breaker Failure Protection” in the same manual, it is clearly mentioned that the parameter “I>BF” is also used for the function “End Fault Protection”.

Figure 4.3-1 End Fault Protection Scheme Block Diagram

While CEB agree with the Committee that End Fault Protection should have received serious consideration of protection staff but as per CEB explanation submitted above the following statements made by the Committee with regard to End Fault Protection Scheme are not correct.

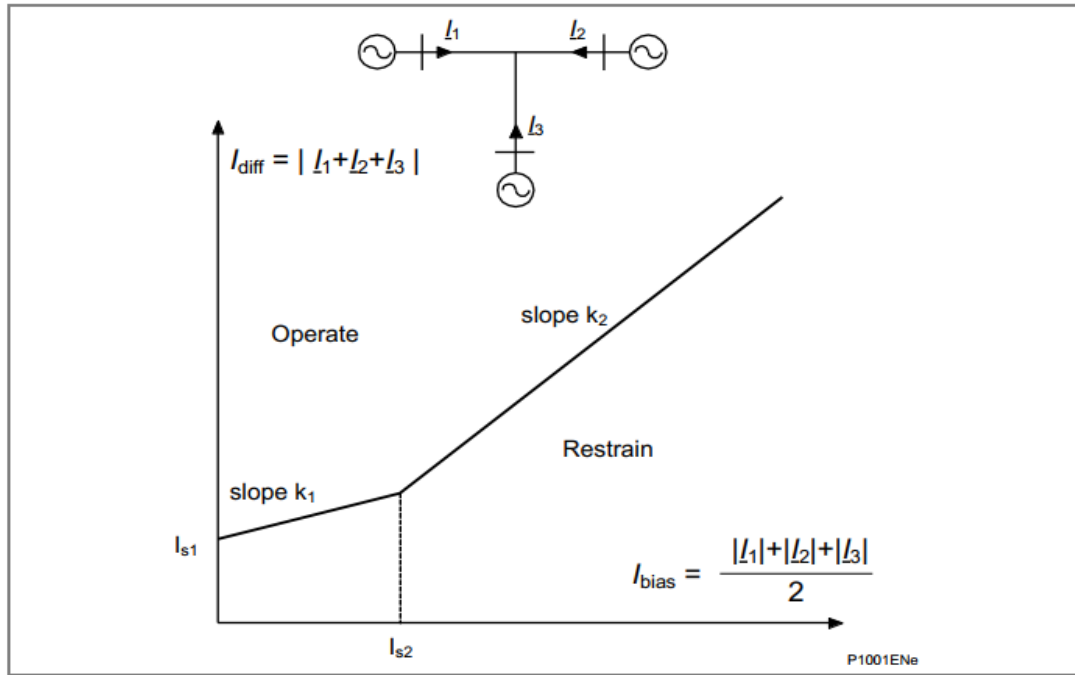
None of the Main 2 (MiCOM) relays have operated during the incident on 2021-12-03. In line 2, the differential current is around 520A. As per the algorithm of differential function of Main 2 relay, fault has not entered the tripping region.

Figure 4.5-1 Relay bias characteristic

As per the above calculation Differential Current Observed (540 A) does not exceed the Min Primary Diff. Cur Requirement for Tripping (584.05 A).

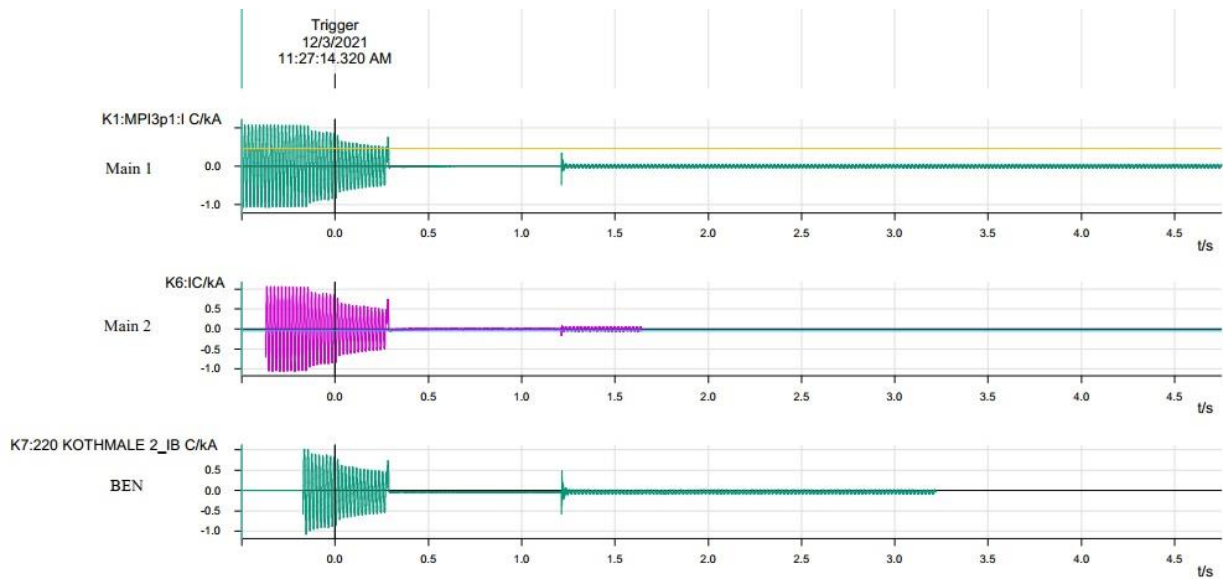
Kothmale – Biyagama line 2 has tripped due to the occurrence of C phase (in ABC notation) to Earth fault (Differential current of 521 A) in the primary side. This fault current has been recorded in Main 1, Main 2 relays and the BEN6000 Digital disturbance recorder at Biyagama GSS. The recorded waveforms from these equipment are shown below:

Figure 6.2-1 Current waveforms seen by Main 1 relay, Main 2 relay and DDR at Biyagama GSS – Kothmale line 2 C phase (in ABC notation)

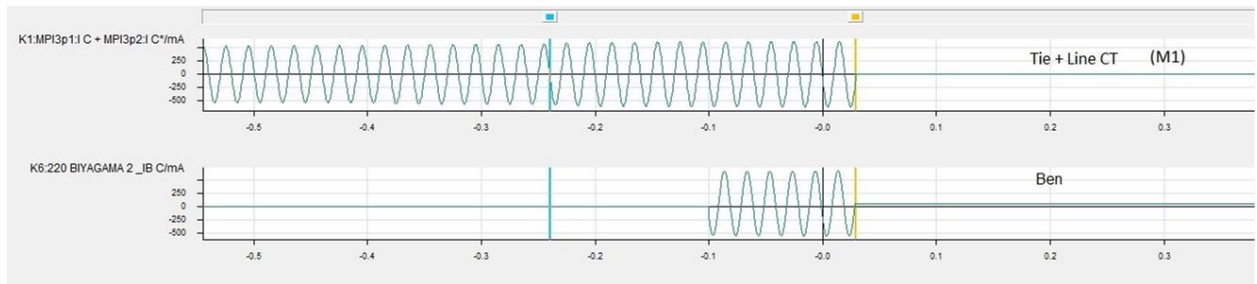
Figure 6.2-2 Current waveforms seen by Main 1 relay and DDR at Kothmale PS – Biyagama line 2 C phase (in ABC notation)

The Main 1 Protection Relay and BEN6000 Digital Disturbance Recorder at Kothmale have also recorded the fault current fed into C phase (in ABC notation) to Earth fault. Screen shots of all the available waveforms of this incident recorded in different devices in both ends of the line are included in [Annex 6.1-1](#).

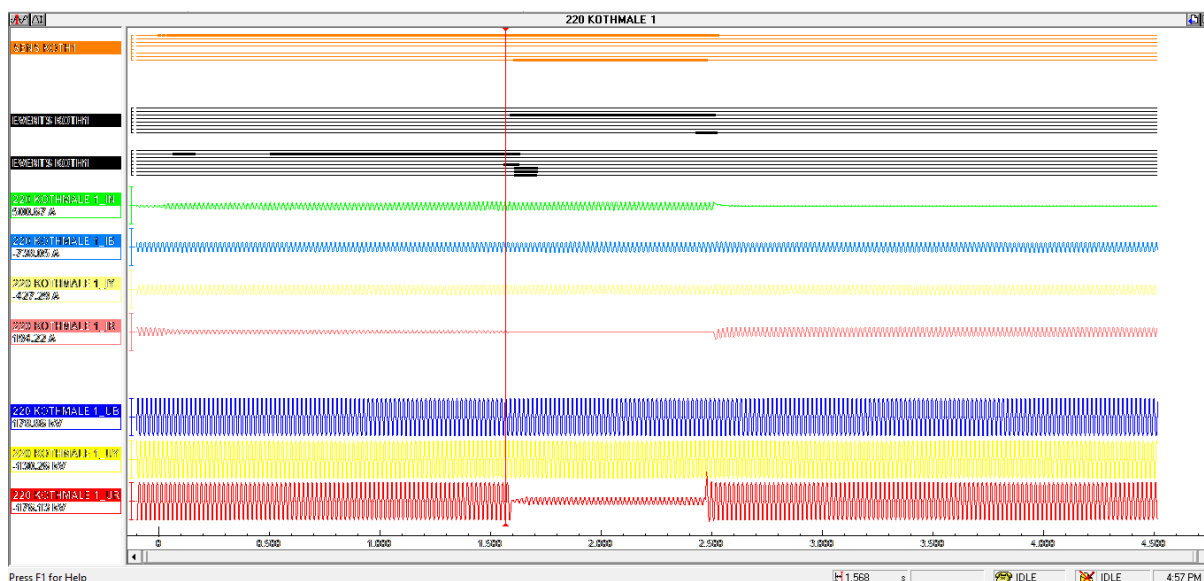
A similar incident in which a high resistive fault, smaller than the load current, causing the operation of differential protection could be observed on 2019-10-18, in which the line has reclosed. (Please refer figure given below)

Figure 6.2-3 Ben 6000 DDR record of Kothmale line 1 at Biyagama GSS at 11:38hrs on 2019-10-18

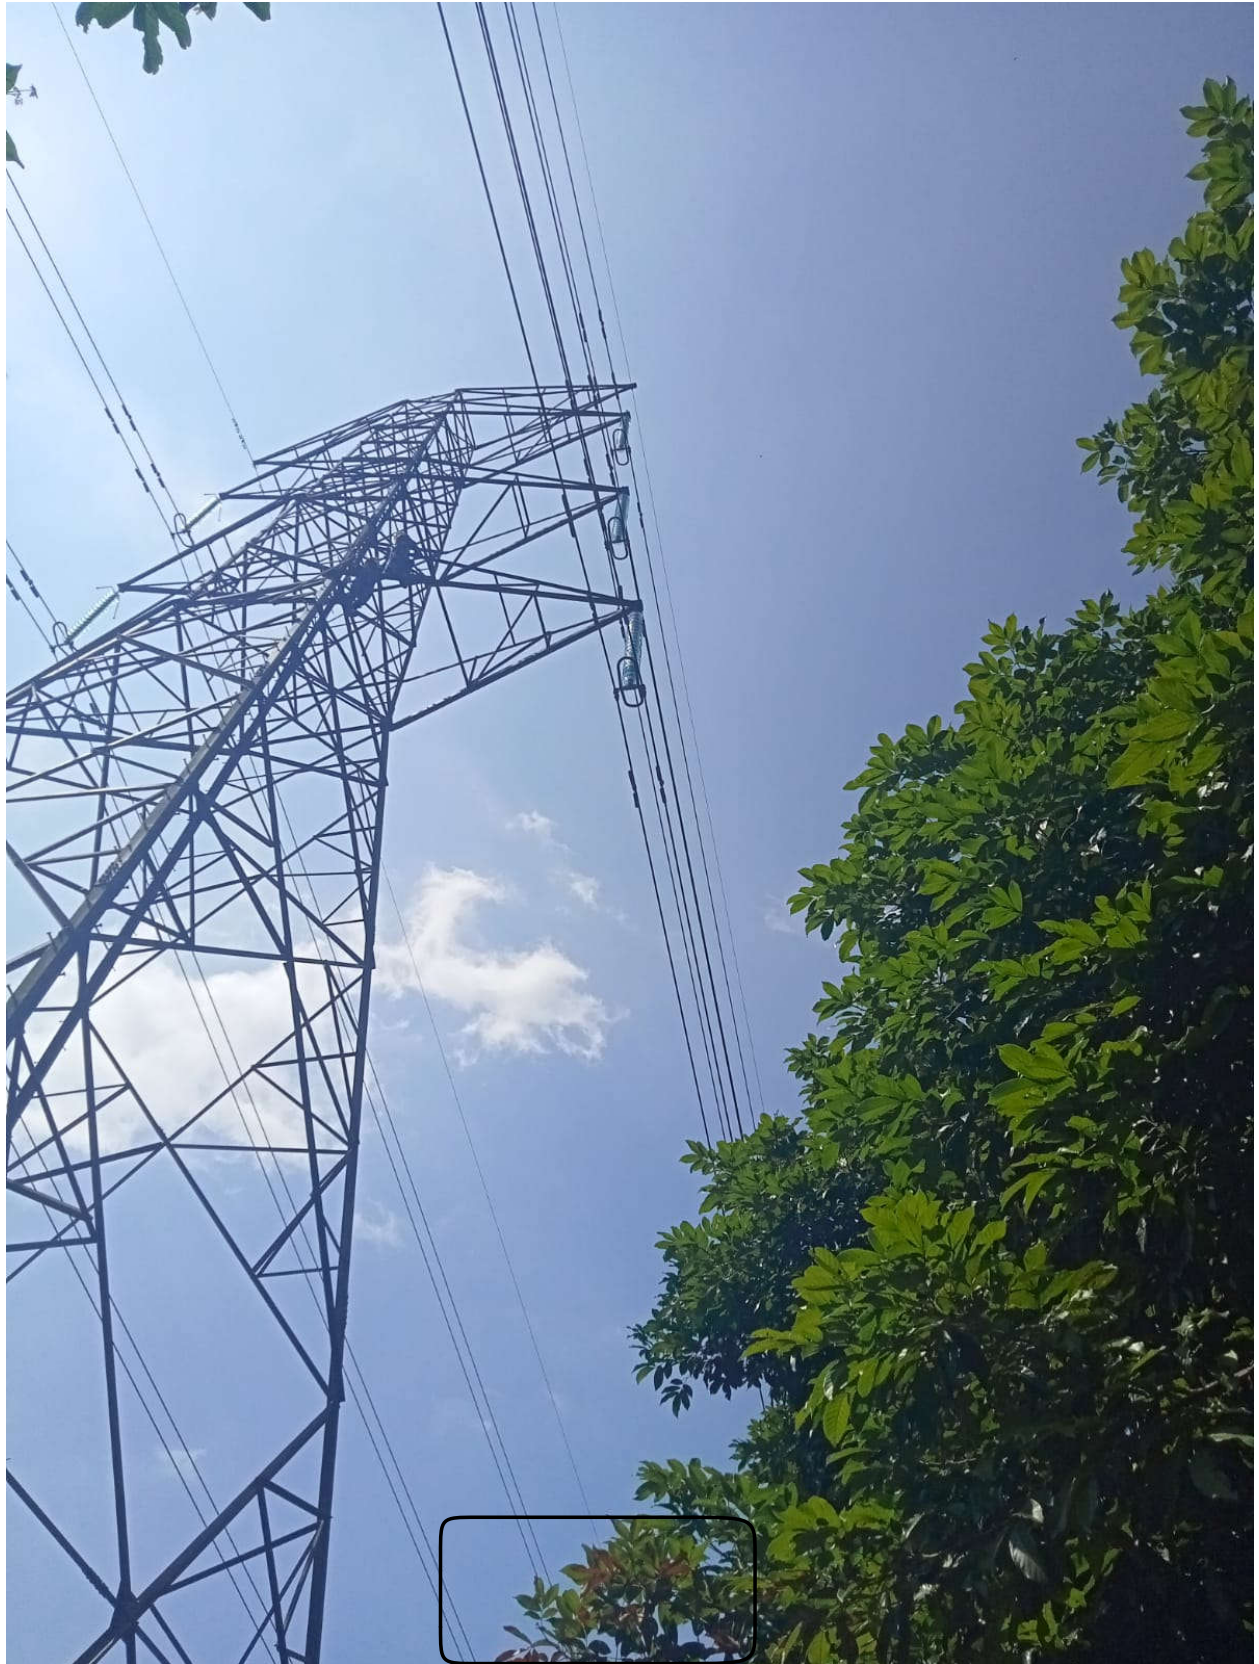
Burnt leaves of near by tree confirming that the fire has been substantial

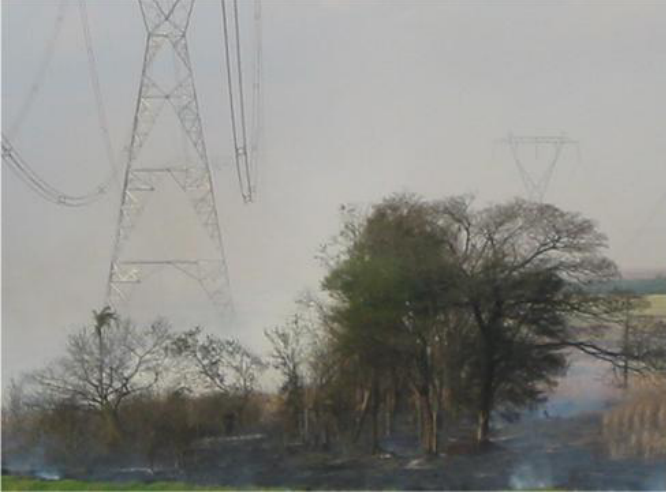
On August 16, 2006, two faults were recorded (at 2:00 p.m. and 2:04 p.m.), with the transmission line opening and reclosing in both cases. At the time, a line maintenance team observed the flashover from the transmission line and the vegetation close to the Paranapanema River, as shown in Fig. 7.

Fig. 7. Fire damage visible at fault location
