**FINDINGS OF THE COMMITTEE APPOINTED TO
INVESTIGATE POWER SYSTEM FAILURES ON
NOVEMBER 29, 2021 AND DECEMBER 03, 2021**

ANNEXES OF THE FINAL REPORT

MINISTRY OF POWER

21.02.2022

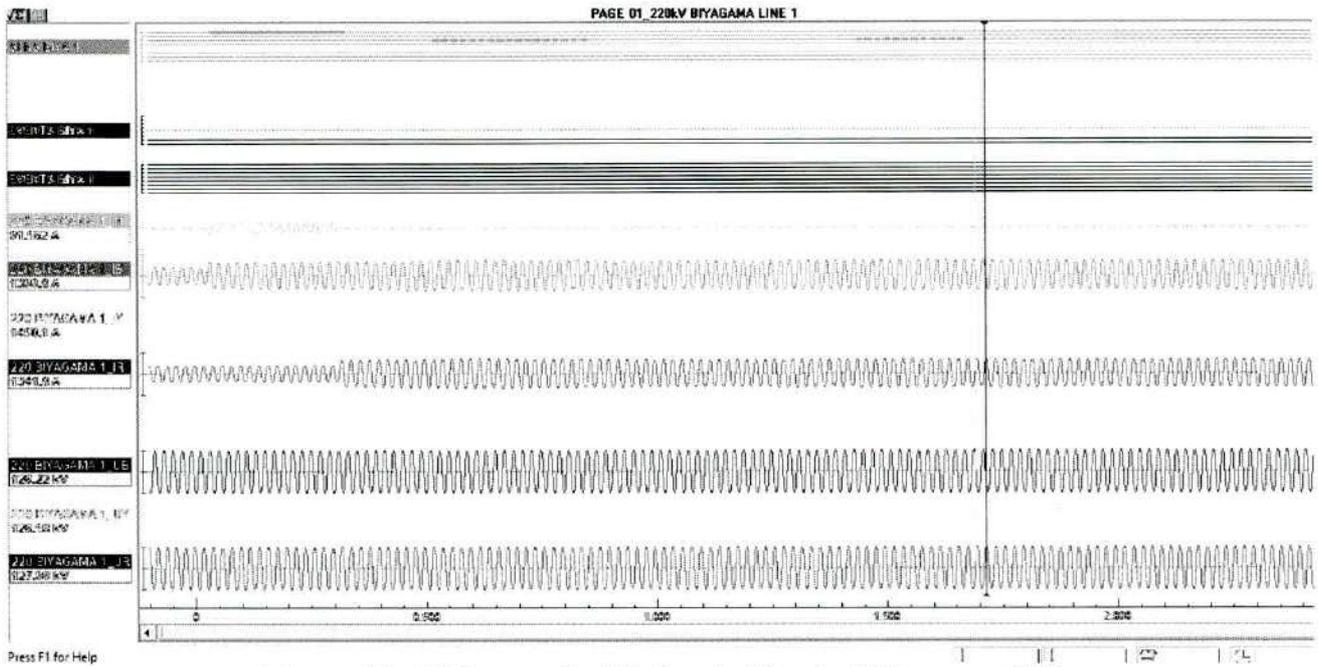
Figure 02: DDR record of Kothmale Line 1 of Biyagama GSS

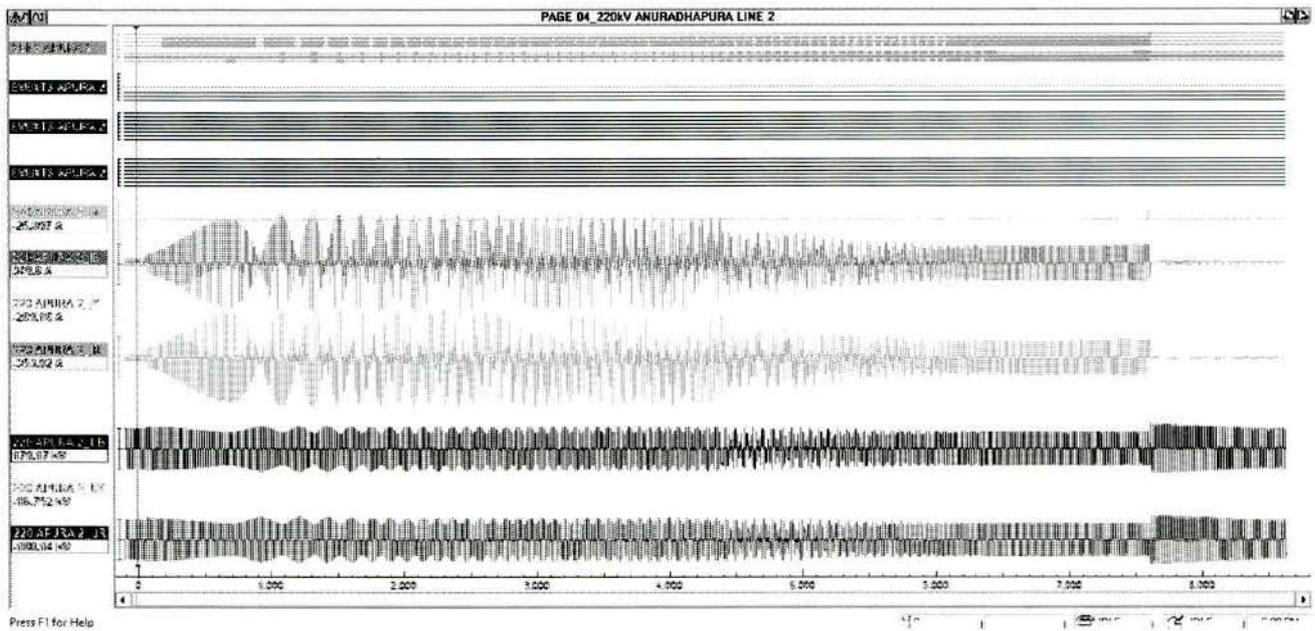
Figure 03: DDR record of New Anuradhapura Line 2 of Kothmale GSS at 11:27:35 Hrs

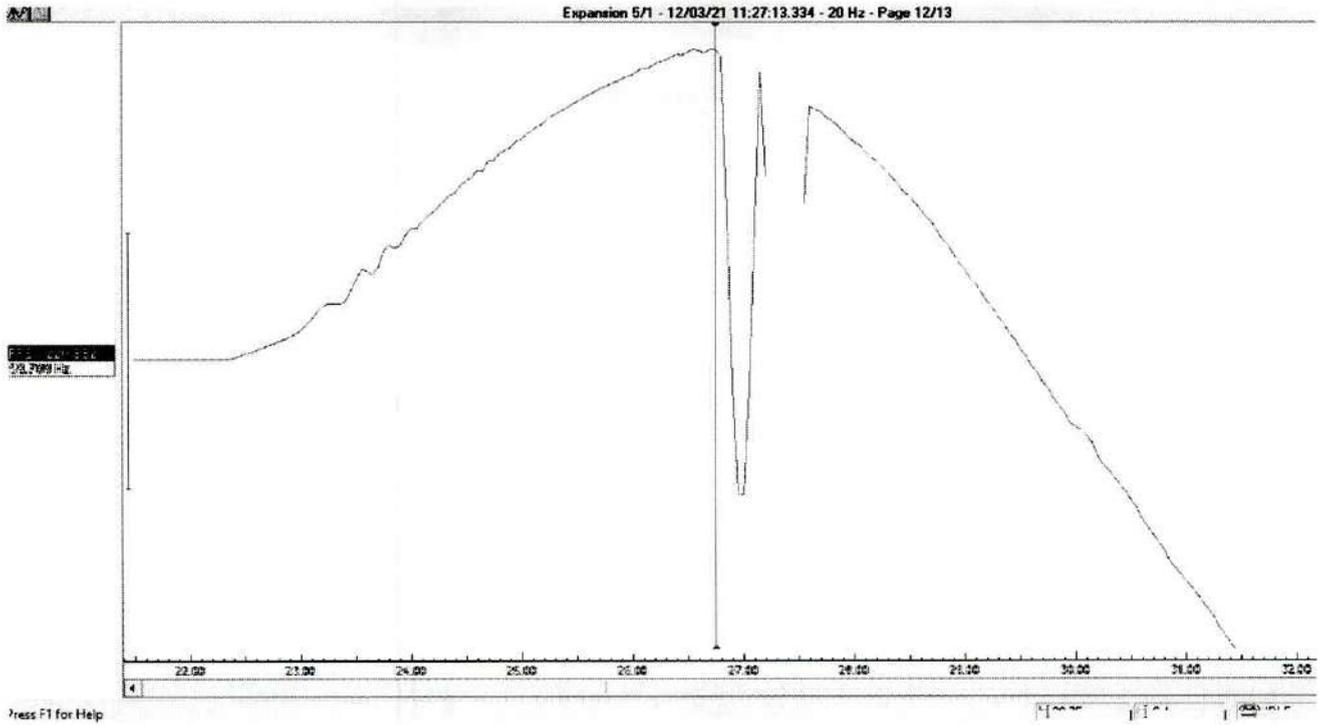
Figure 04: Frequency variation at Kothmale 220kV Bus

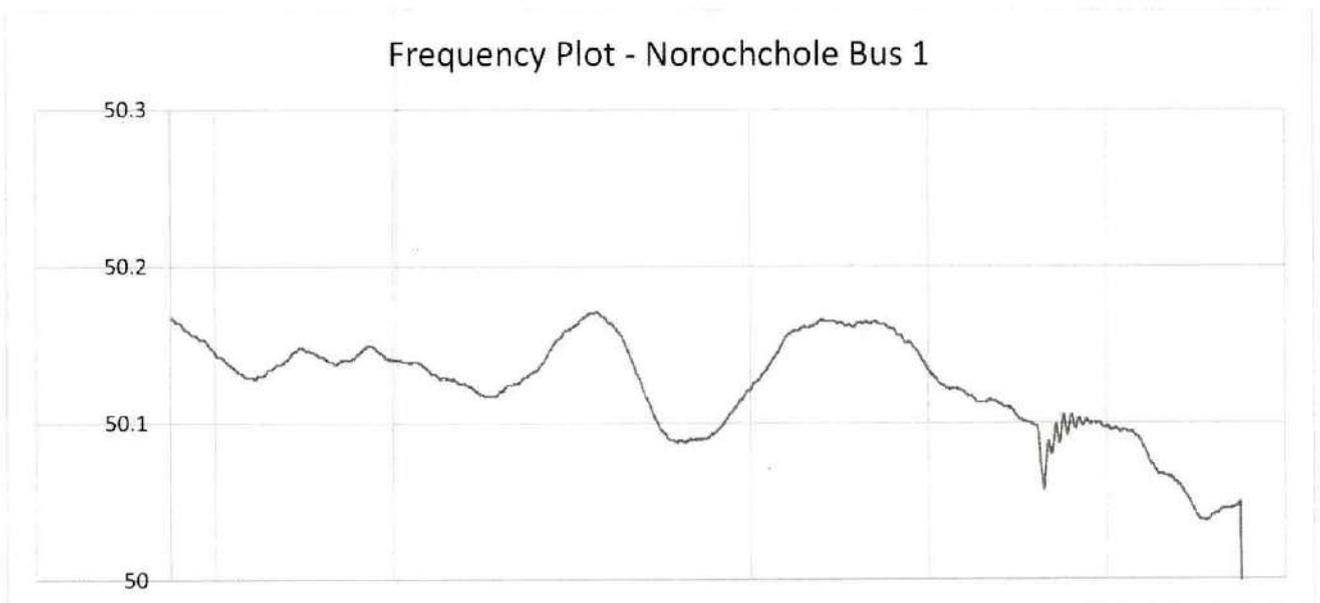
Figure 05: Frequency variation at Norochholei GSS 220kV Bus 1 during the failure

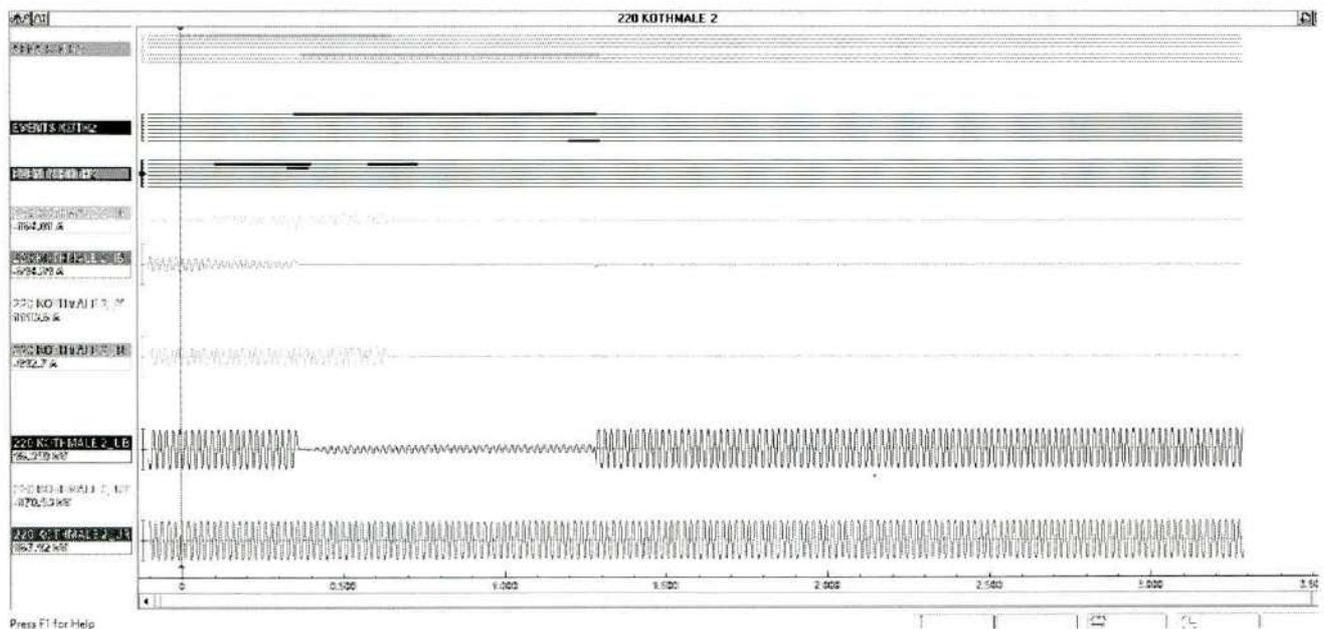
Figure 01: DDR record of Kothmale Line 2 of Biyagama GSS at 11:27:14 Hrs

It is observed that the C phase to earth fault current of approximately 520A detected in Main 1, Main 2 relays and BEN DDR of Kothmale – Biyagama line 2. Main 1 relay is connected to Core 1 of current transformer while Main 2 and DDR are connected to core 2. Similar fault current waveforms were observed in all three devices (figure 06). Zero sequence current fed to the fault from Biyagama end is approximately 390A and a zero sequence current of 90A could be observed in the fault records in Kothmale end of Line 2. Additionally, it is observed that the summation of zero sequence currents observed in all connected 220kV bays at Biyagama GSS prior to the tripping of Kothmale line 02 equals the zero-sequence current flowing in Kothmale line 2. This zero-sequence current has been cleared with the tripping of phase C. Hence it is clear that there has been a primary fault in the line.

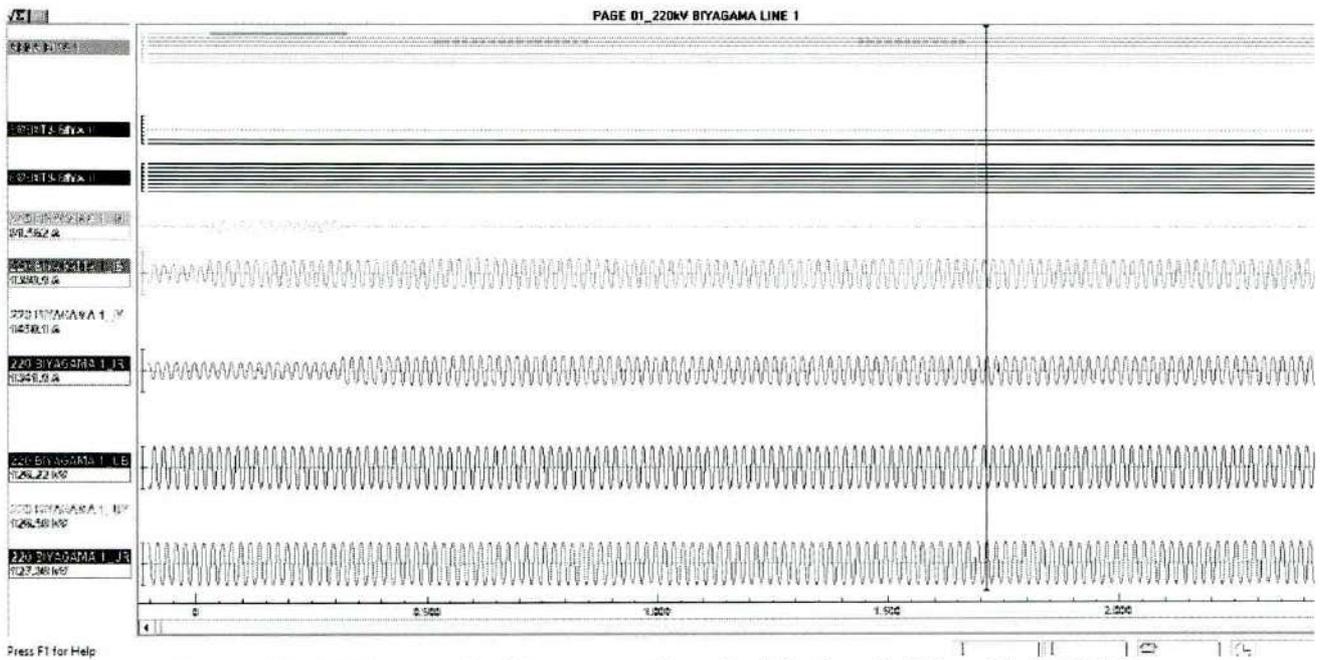
Figure 02: DDR record of Biyagama Line 1 of Kothmale PS at 11:27:14 Hrs

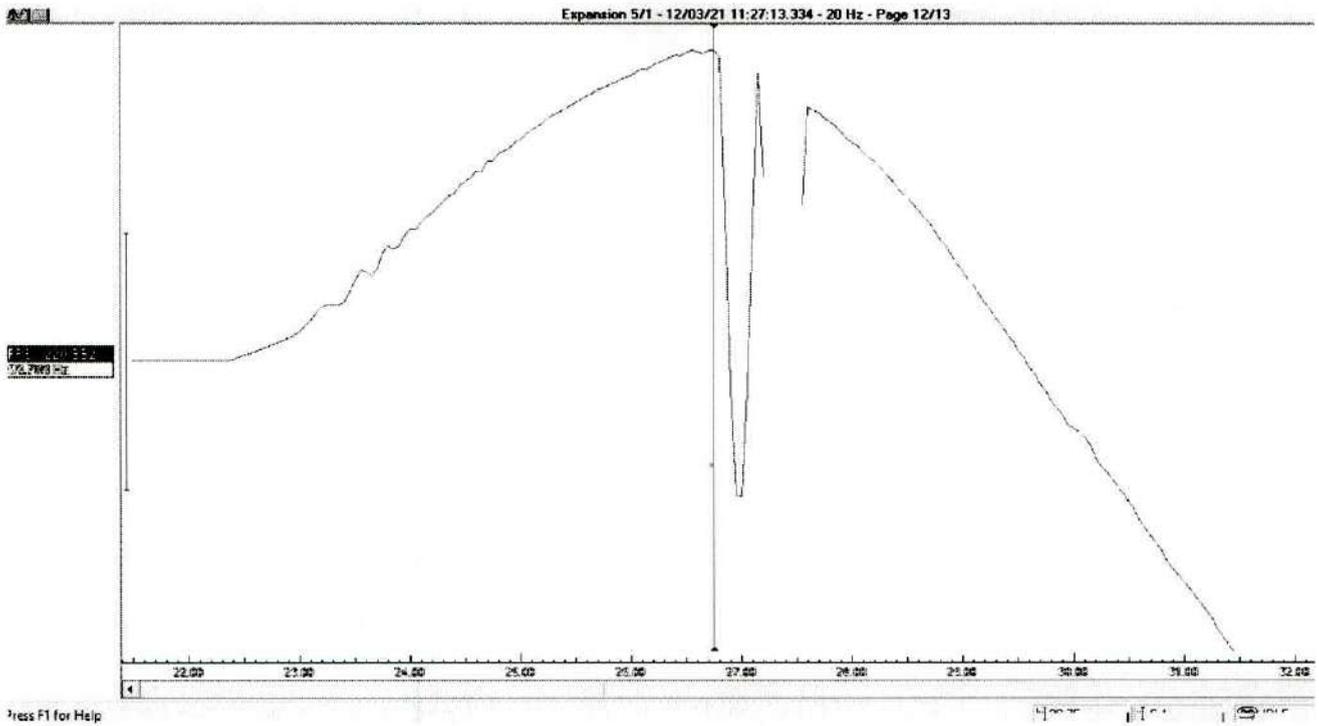
Figure 04: Frequency variation at Kothmale 220kV Bus

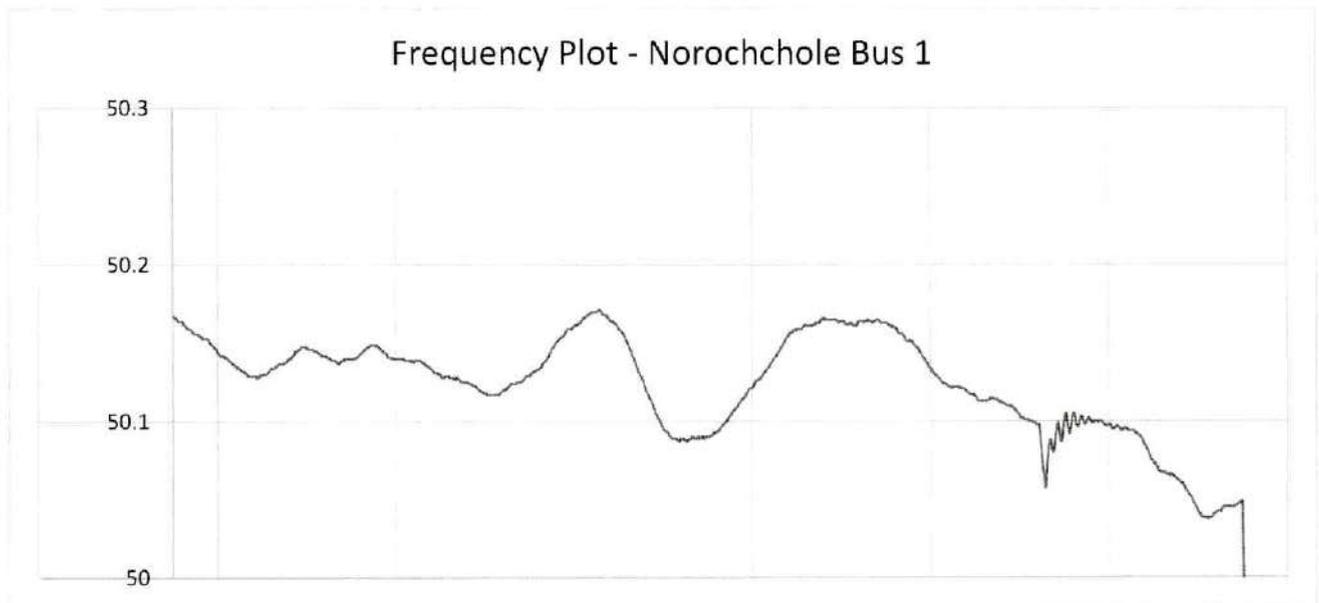
Figure 05: Frequency variation at Norochcholei GSS 220kV Bus 1 during the failure

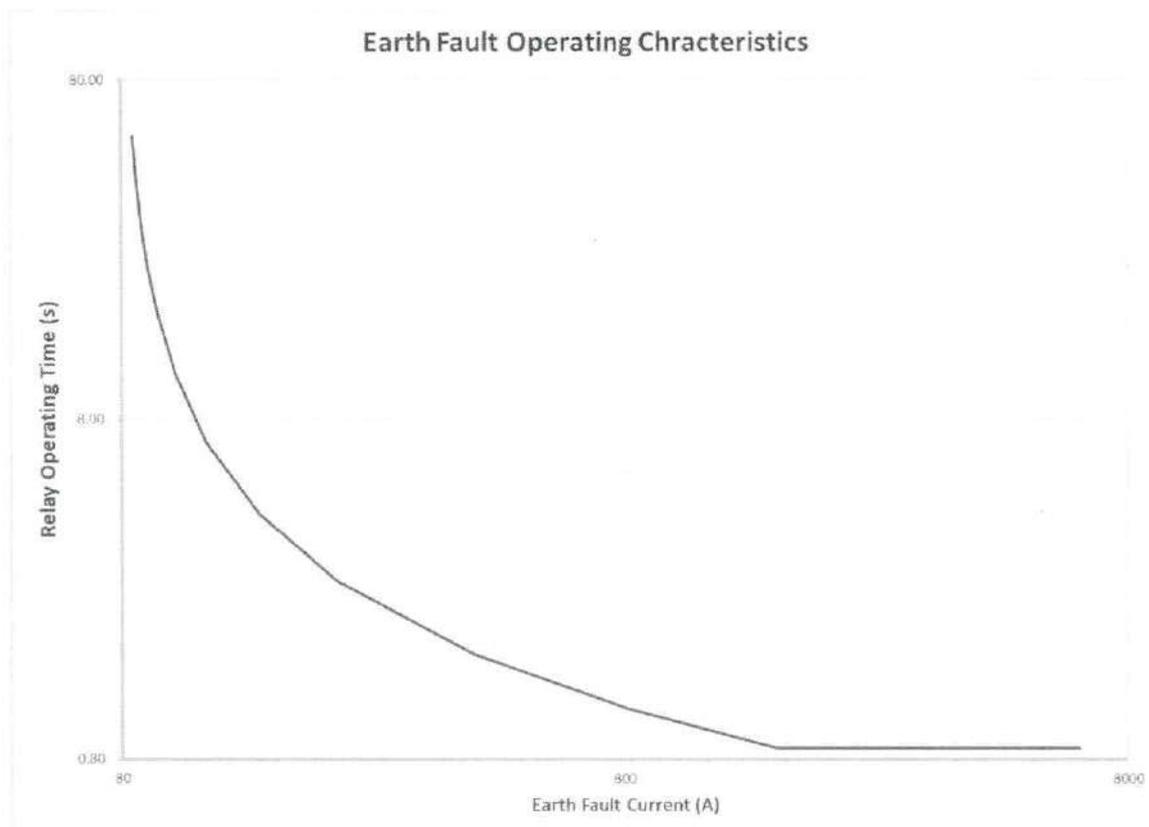
Figure 04: Operating characteristic of the Non directional earth fault protection function of Main 01 relay at Biyagama line 1 at Kothmale PS

“despite the neutral current having become zero after 288ms from the pickup.” – This is an incorrect statement since the neutral current of line 01 did not become zero until it trips. In the mutual line compensation wiring available in these two circuits, neutral of the parallel circuit is wired to the protection relay. Neutral current shown in Main 01 relay of line 01 is the neutral current of the line 02 which has tripped approx.. in 288ms. This could have lead to the above misleading statement.

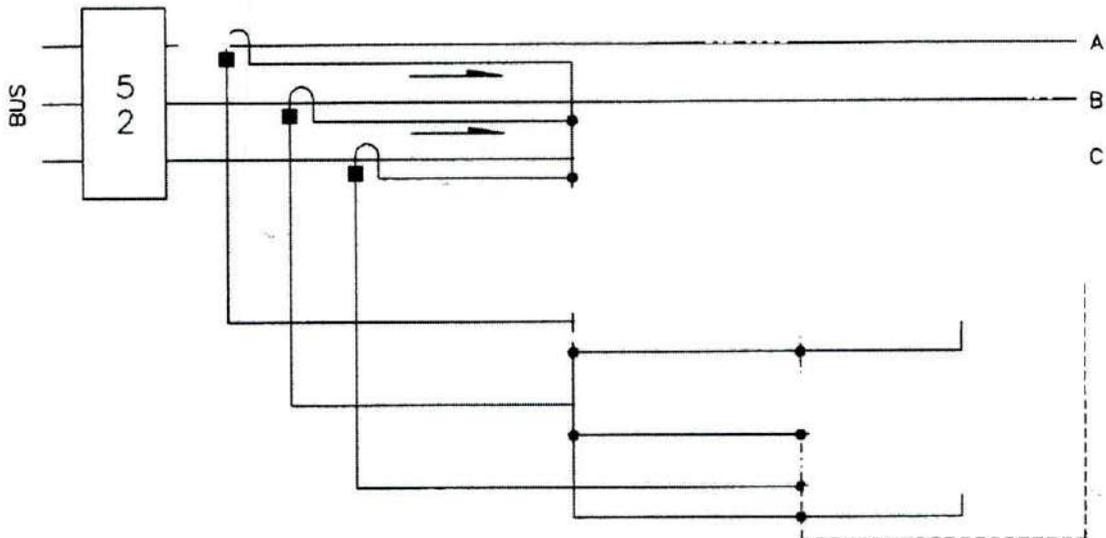
Figure 10 shows an actual accidental miswiring of the CT neutral wire circuit: the neutral return from the relay to the CTs is omitted. The information contained in the microprocessor relay event report led the protection engineer to discover the missing wire. On May 5, 1995, the transmission line experienced two faults. The first fault location read 36.19 miles, while the second event displayed a fault location of 11.93 miles. The initial fault was a phase-phase fault, while the second fault was C-ground. These two faults were separated by 0.508 seconds. The fault locations were believable as the line length is 42.5 miles. Were there two different faults at different locations so close together in time?

Figure 10: Missing Current Neutral Wiring Diagram

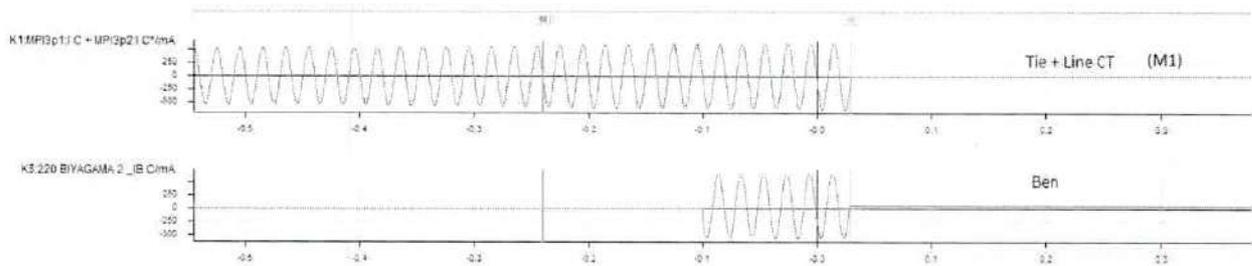
Figure 02: Current waveforms seen by Main 1 relay and DDR at Kothmale PS – Biyagama line 2 C phase (In ABC notation)

The Main 1 Protection Relay and BEN6000 Digital Disturbance Recorder at Kothmale have also recorded the fault current fed into C phase (ABC notation) to Earth fault. Screen shots of all the available waveforms of this incident recorded in different devices in both ends of the line are included in Annex 1.2.

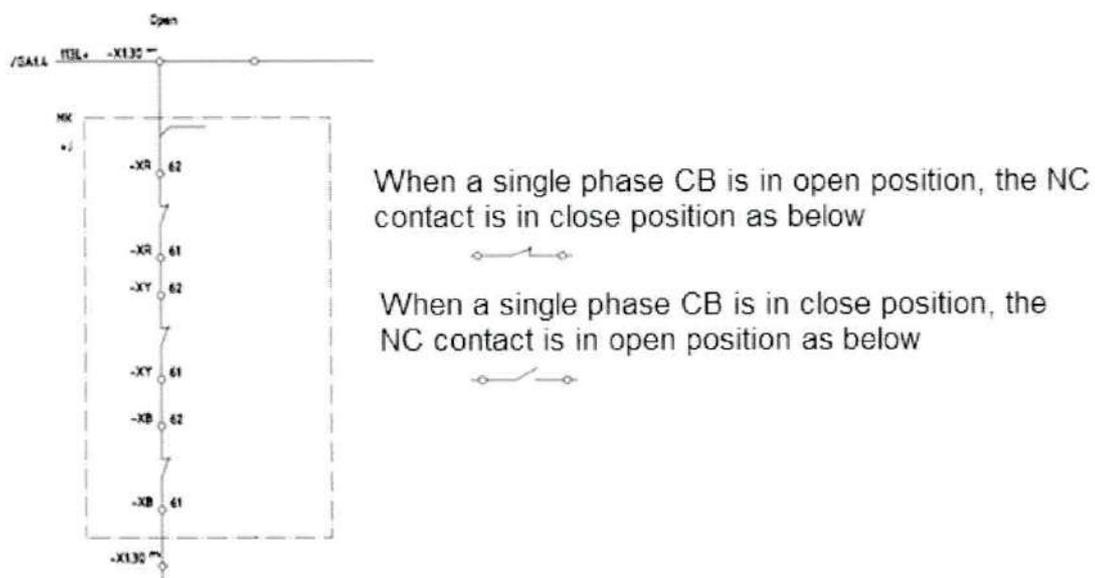
In order to correct operation of the end fault protection, accurate CB position shall be fed into the Busbar Protection relay (Siemens 7SS52). In Biyagama GS as per the drawing a series of Normally Closed (NC) contacts of CB – R phase, CB – Y phase and CB – B phase are used to detect the CB open condition when all the three phases are in open position as follows,

Figure 04: Connection of circuit breaker status required as per the drawing

As per the existing wiring paralleling of NC (Normally Closed) contacts were used to give the opening of all three phases to the Busbar Protection relay. Please refer below drawing. This scheme is incorrect and should be serially connected as above Figure 04.

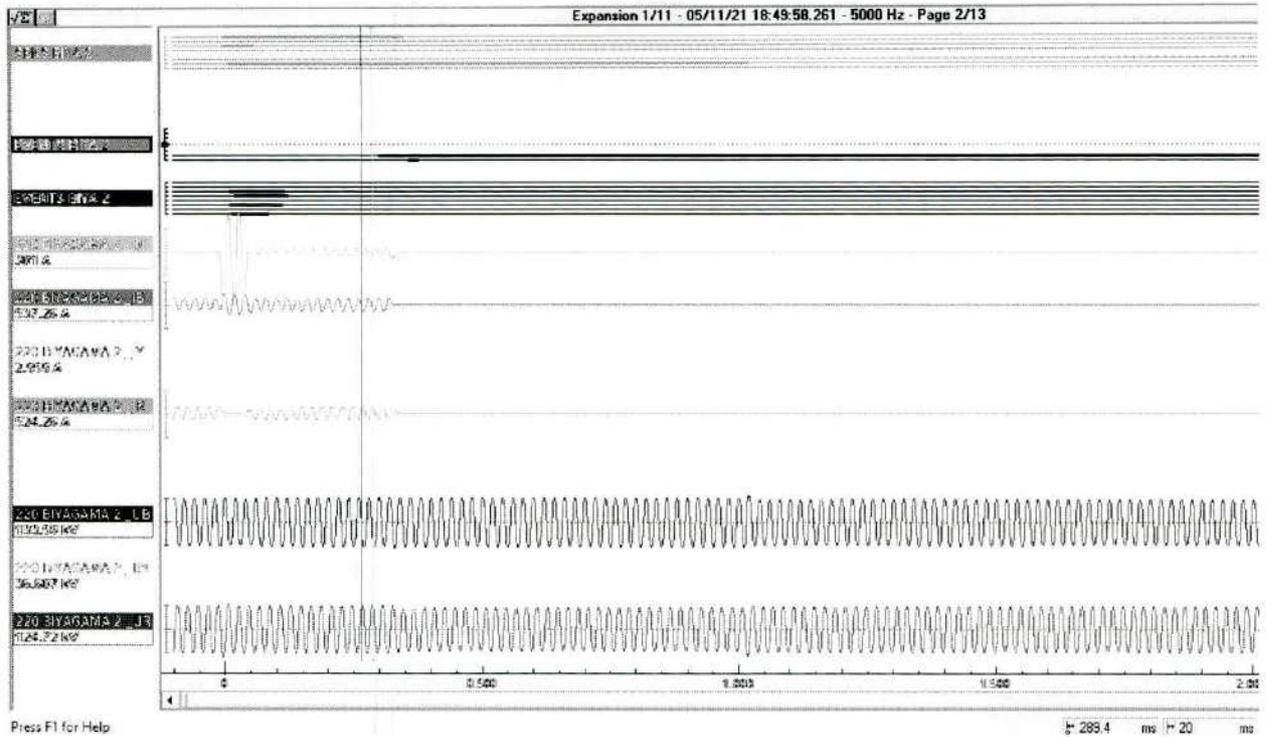
In all of the above three incidents end fault protection has operated due to the incorrect circuit breaker status received and additionally the currents of healthy phases are above the threshold current required for end fault function to be activated.

Figure 12: Ben 6000 DDR record of Biyagama line 2 at Kothmale PS at 18:49 on 2021-05-11

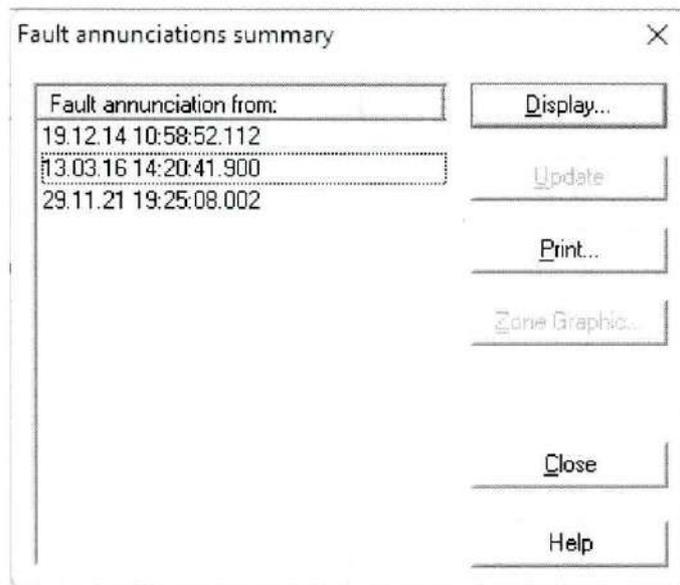
Fault annunciation in the bus bar bay unit of Kothmale line 01 shows 3 events in which operation of End fault protection on 2021-11-29 is one of them. Other two incidents refer to bus bar protection trip on 2016-03-13 and an event prior to commissioning of the system in 2014.

Figure 13: Busbar protection fault annunciation log of Kothmale line 01

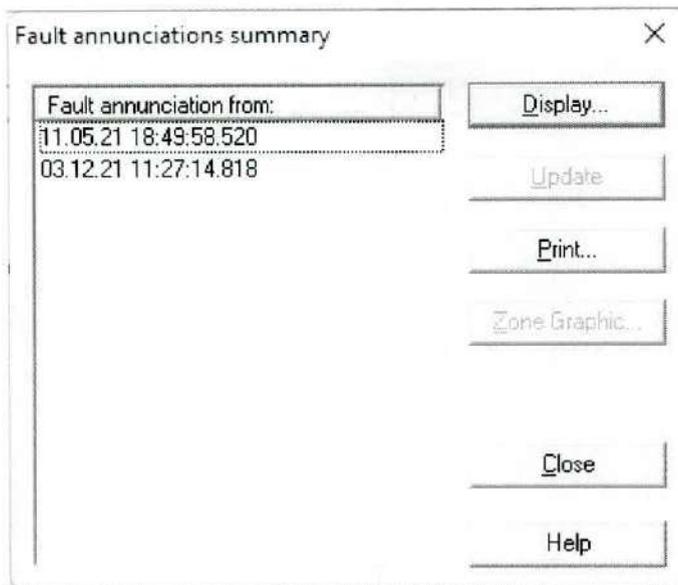
Fault annunciation in the bus bar bay unit of Kothmale line 02 shows two incidents in which End Fault has operated in both instances.

Figure 16: Busbar protection fault annunciation log of Kothmale line 02

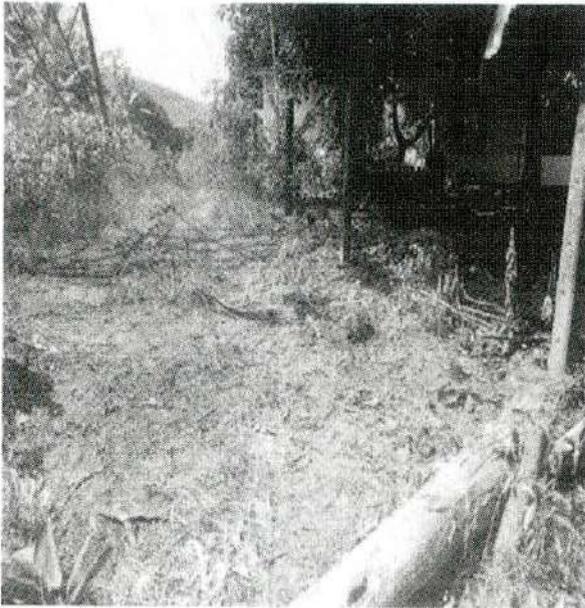
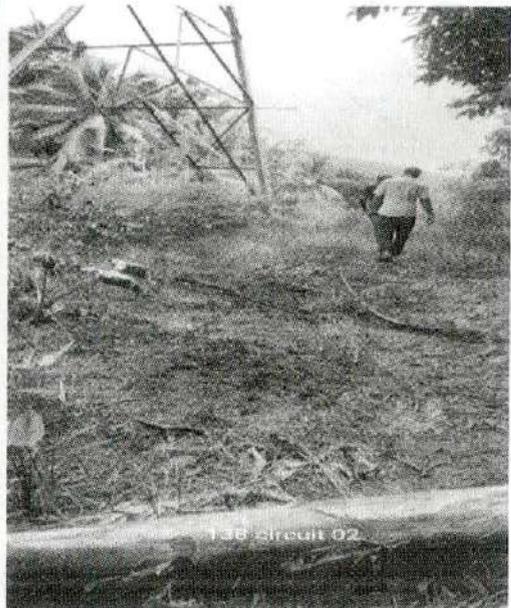
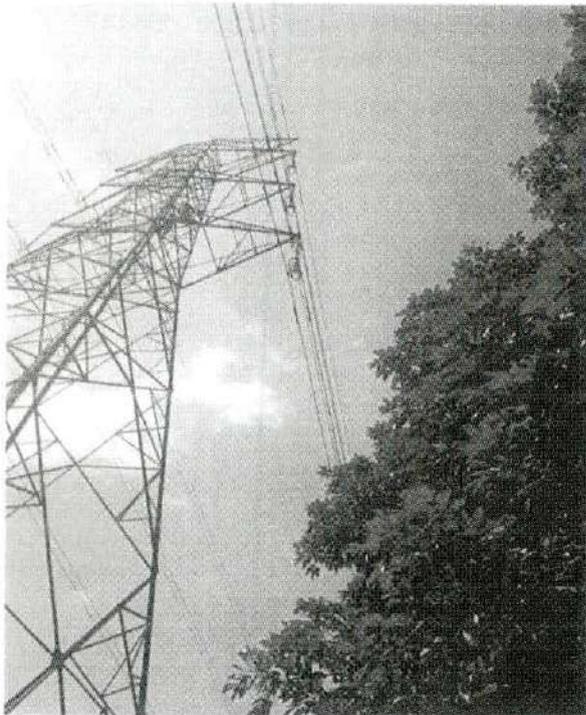
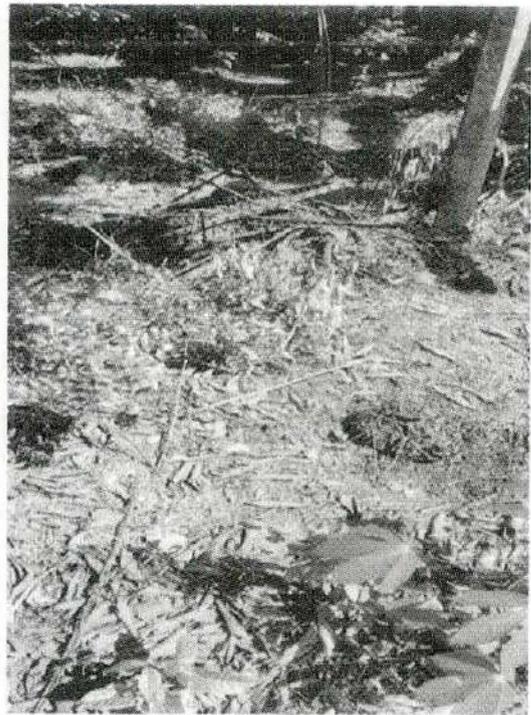
Fire under the Tower no 138
