**FINDINGS OF THE COMMITTEE APPOINTED TO
INVESTIGATE POWER SYSTEM FAILURES ON
NOVEMBER 29, 2021 AND DECEMBER 03, 2021**

**MINISTRY OF POWER
SRI LANKA**

**Final Report
February 21, 2022**

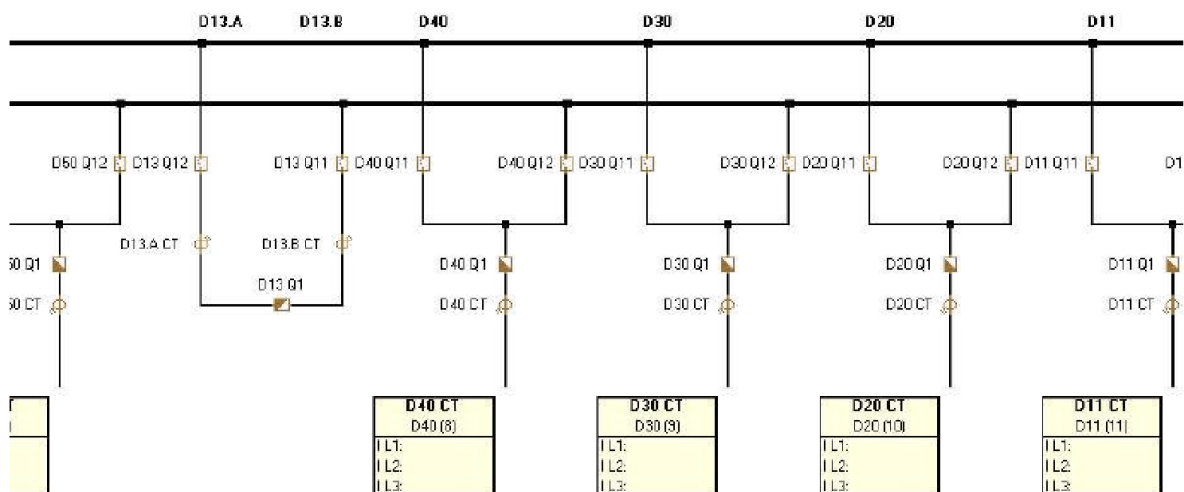
Figure 2.2 - Part of the Busbar and Feeder Layout in Biyagama GS

Part of the single-line representation of the Biyagama double busbar system obtained from the busbar protection relay software DIGSI V4.93 is shown in Figure 2.2. The feeder D30 on Bay 9 is the circuit 2 of Kotmale-Biyagama 220 kV transmission line, where D30Q11 is the Busbar 1 isolator and the D30Q12 is the Busbar 2 isolator, and the CT D30CT is on the line side after the CB indicated as D30Q1. The CT covers all 3 phases as indicated by IL1, IL2 and IL3 under D30(9).

As already discussed above, before the completion of the auto-reclosing of phase B of circuit 2, the end-fault tripping signal had been issued by the relay SIEMENS 7SS522 at the Biyagama GS, causing circuit 2 to be locked out at the Kotmale end. This event is marked as “Power System Fault/D30EFPTR ON at 11:27:14.826” highlighted in red in Figure 2.3, reproduced from the downloaded relay logs. The end-fault protection is designed to protect equipment in the event of an earth fault occurring between the CB and the CT, both of which are inside

the Biyagama GS. The operation of end-fault protection of circuit 2 without an actual end-fault highlights a serious flaw inherent in the implementation of this protection scheme.

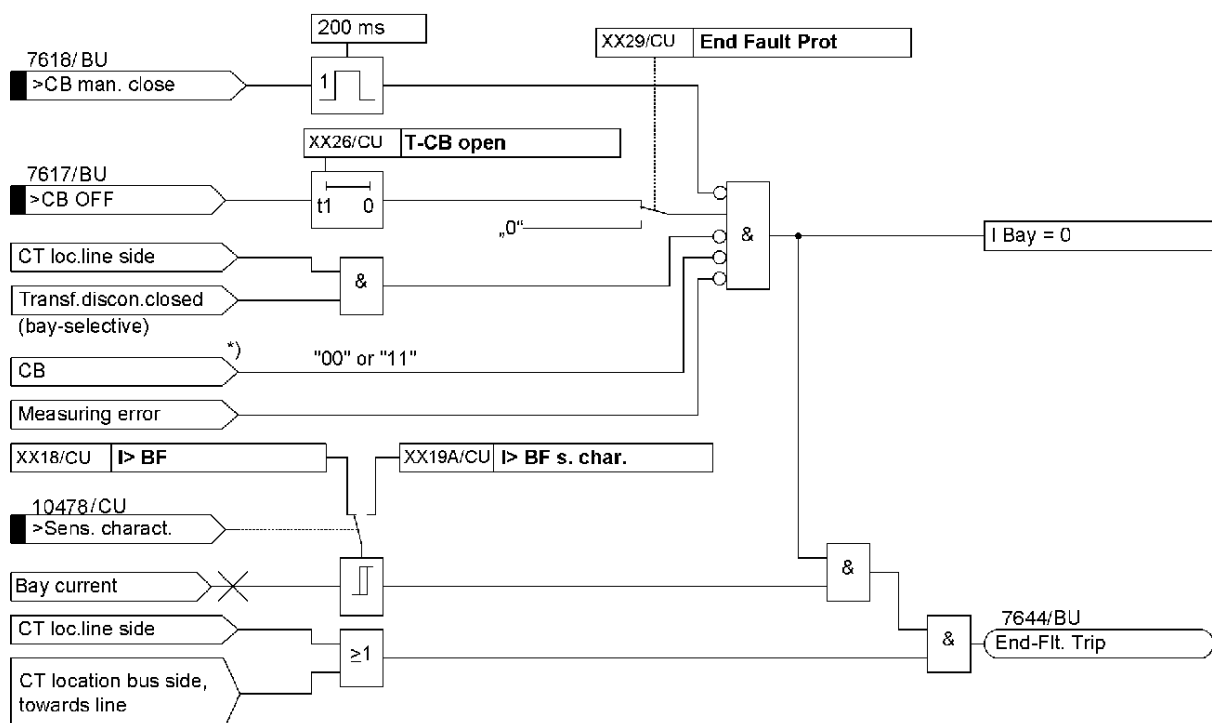
Figure 2.6 – End-Fault Function Implementation in the SIEMENS 7SS522 Relay Manual

The operation manual of the SIEMENS 7SS522 relay confirms that the end-fault function is for the detection and disconnection of short-circuits between CT and CB of a line. The logic of the end-fault protection is reproduced in Figure 2.6. A prerequisite for the activation of end-fault protection is that the CB open state ">CB OFF" (7617/BU) is marshalled to a binary input.

During the auto-reclosure operation, until the CB is closed and the feeder current is integrated into the busbar measurement again, the end-fault protection should remain blocked. The leading information of the CB CLOSE command is evaluated (" $>CB$ man.close" 7618/BU) and marshalled to a binary input. According to the relay manual (page 156), end-fault protection is blocked if the monitoring of the switching status feedback has detected a fault. However, it appears that despite the phase B fault having been detected and disconnected by SIEMENS 7SL87 relay (Main 1 line protection relay), initiating an auto-reclosure process, the status communication has not been correctly taken as an input. Such provision had not been present in the relay configuration at the time of the two incidents of November 29, 2021 (on circuit 1) and December 03, 2021 (on circuit 2). It is further proof that this matter should have received serious consideration of the CEB's protection staff without waiting for this Committee to raise the issue.

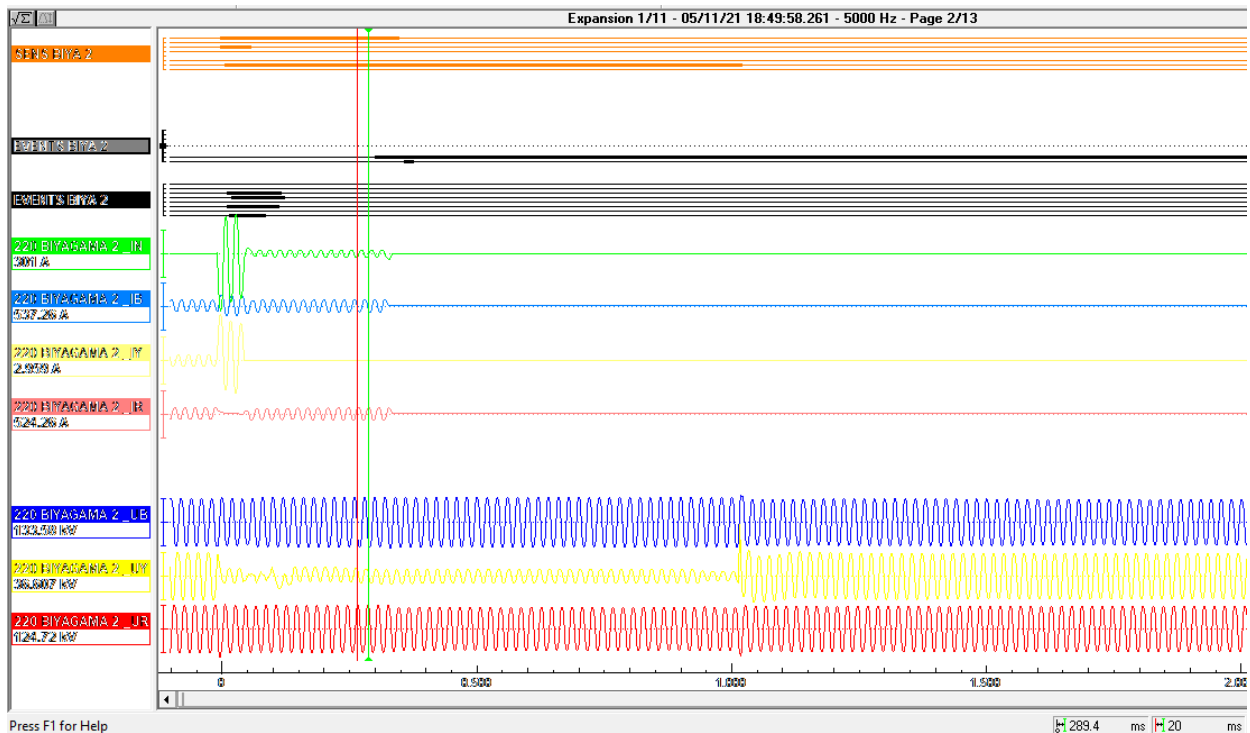
Figure 2.10 – DFR Record of Event in Circuit 2 of Kotmale-Biyagama 220 kV Transmission Line at 18:49 on May 11, 2021

Example 1: End-fault protection operated with lockout in circuit 2 of Kotmale-Biyagama 220 kV transmission line at 18:49 on the May 11, 2021 following a phase Y to ground fault, where the currents in the healthy phases have been above 500 A. The corresponding record on the DFR is shown in Figure 2.10.

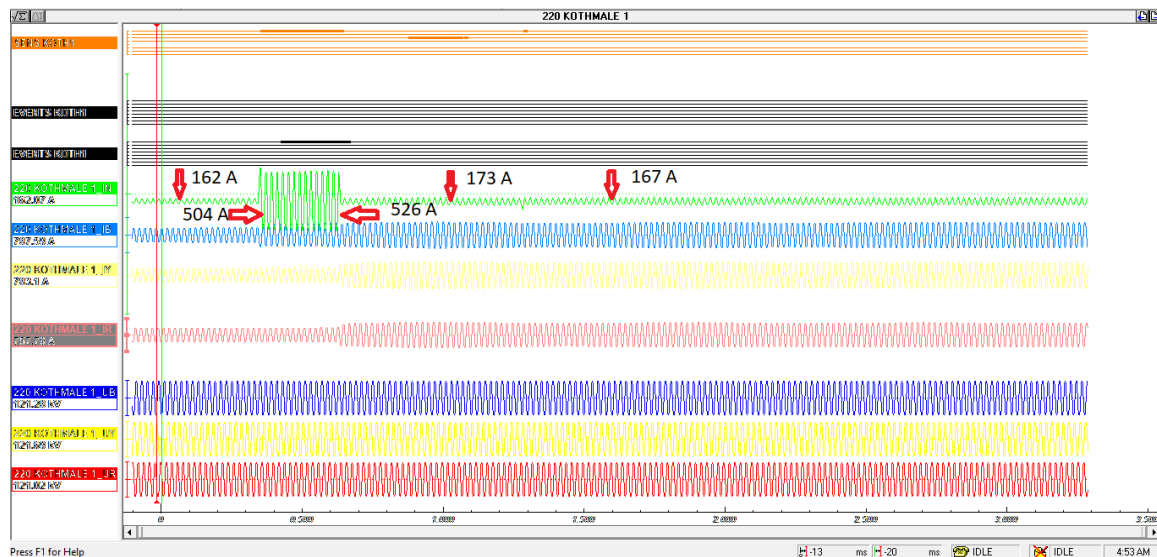
Figure 2.13 – DFR Records of Circuit 1 of Kotmale- Biyagama 220 kV Transmission Line at Biyagama End on December 03, 2021 at 11:27:14

The information on the neutral current revealed in the downloaded DFR (BEN6000) records at Biyagama GS are given in Table 2.4 and the corresponding DFR records are shown in Figure 2.13. The BEN6000 records downloaded at Kotmale substation are given in Figure 2.14. According to these records, the pre-fault neutral currents recorded at the two ends are significantly different (162 A and 70 A for the two ends). The same observation was made when the Committee visited the NSCC on December 06, 2021, where it was observed that the values were 139 A and 61 A respectively for the two ends. This current off-set could have been due to a calibration error in the DFR (BEN6000) or mismatch of the CT secondary at the two ends, or a combination of both. The Committee requested the Ministry of Power to get the original equipment manufacturer (OEM) to check on this discrepancy and the OEM has submitted the calibration report confirming that there had been a calibration error and that has now been corrected.

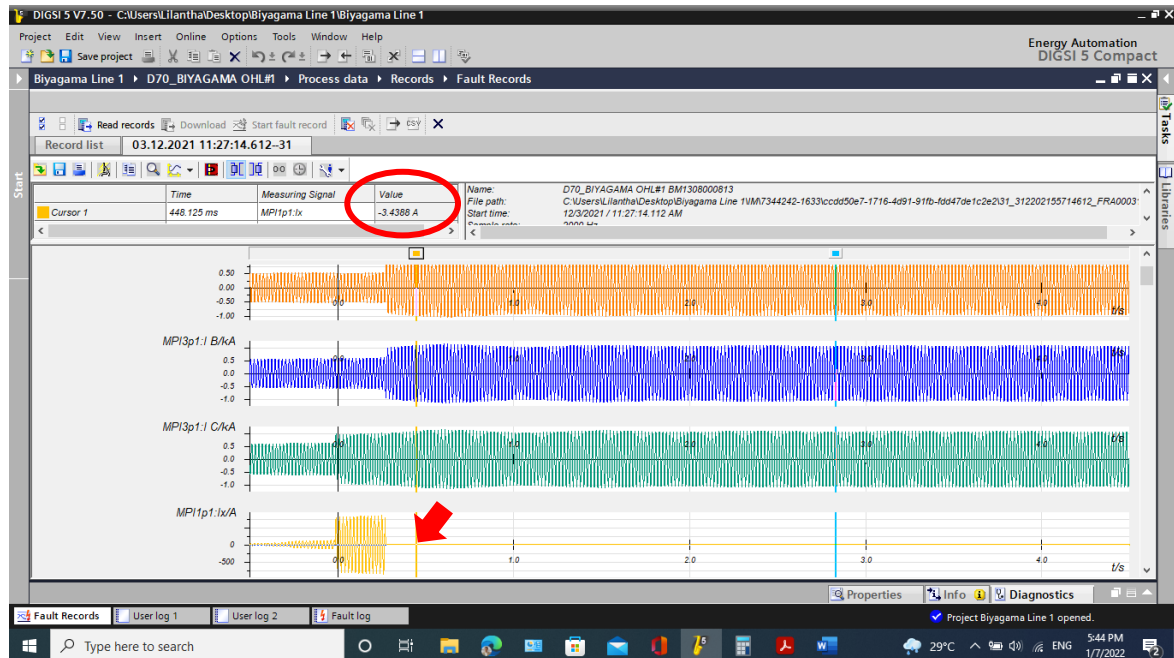
Figure 2.15 – Main 1 Relay Disturbance Record of Circuit 1 of Kotmale-Biyagama 220 kV Transmission Line

Because of the possible calibration error of the DFR records, Contrade Viewer 4.5 SIEMENS AG software was used to access the SIEMENS 7SL87 relay setting file where the voltage, current and trigger signals can be viewed. Figure 2.15 shows the screenshot of fault records of the SIEMENS 7SL87 protection relay of circuit 1 as recorded in the relay. These records are consistent with the CEB's explanation that the neutral current shown in Main 1 relay of

circuit 1 is the neutral current of circuit 2, since the current has become almost zero following the circuit 2 tripping.

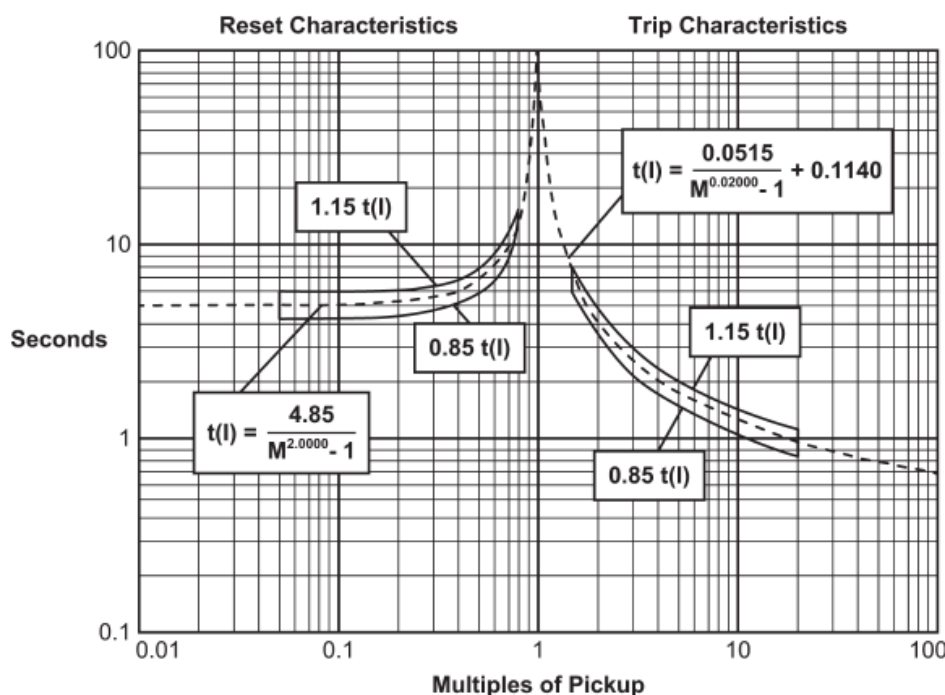
Figure 2.17 - IEEE Standard C37.112-2018 for Over Current Relays

However, neither the calculation by CEB nor the explanation by Mr. Ren YiQiang of SIEMENS Power Automation Limited (ea_support.cn@siemens.com), whose email has been quoted by CEB in the report to the Committee (who has been replying on behalf of the OEM of SIEMENS 7SL87), seems to have followed the IEC 60255-151 (IEEE Standard C37.112-2018), which is the standard pertaining to earth-fault relay resetting. The standard very clearly specifies the inverse time reset curve, whose Plug Setting Multiplier is below 1 ($PSM < 1$), which is very different to the IEC standard inverse time trip curve ($PSM > 1$) as reproduced from the standard⁷ in Figure 2.17.

Hence, even though the answer for the tripping time calculated (22.33 s) agrees with the actual operating time with the associated tolerances, the method followed in the calculation does not comply with the reset characteristics in the industry standards. Nevertheless, the operation of the relay is recorded in the fault log of the relay as shown in Figure 2.18, which is consistent with information provided by BEN6000 at the Kotmale end for circuit 2.

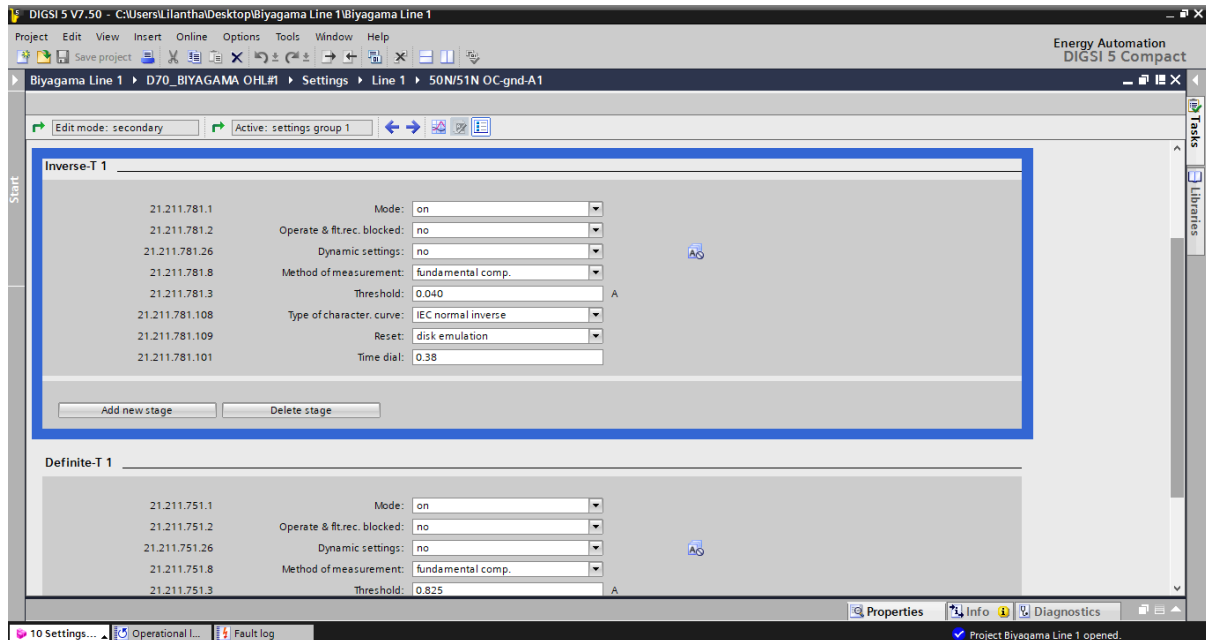
Figure 2.19 - 50N/51N OC-gnd-A1 Settings of SIEMENS 7SL87 in Circuit 1 of Kotmale-Biyagama 220 kV Transmission Line at Kotmale Substation

The Committee has determined that had the “Reset” of the relay of circuit 1 been configured to “Instantaneous” instead of “Disk Emulation”, the operation of the earth-fault protection “50N/51N OC-gnd-A1” upon the neutral current returning to 65 A would not have happened. In that case, circuit 1 would have survived, and the total power failure should have been avoided. The corresponding calculation is given below:

The relay settings as recorded in the Kotmale substation and Biyagama GS are shown in Figure 2.19 and Figure 2.20 respectively.

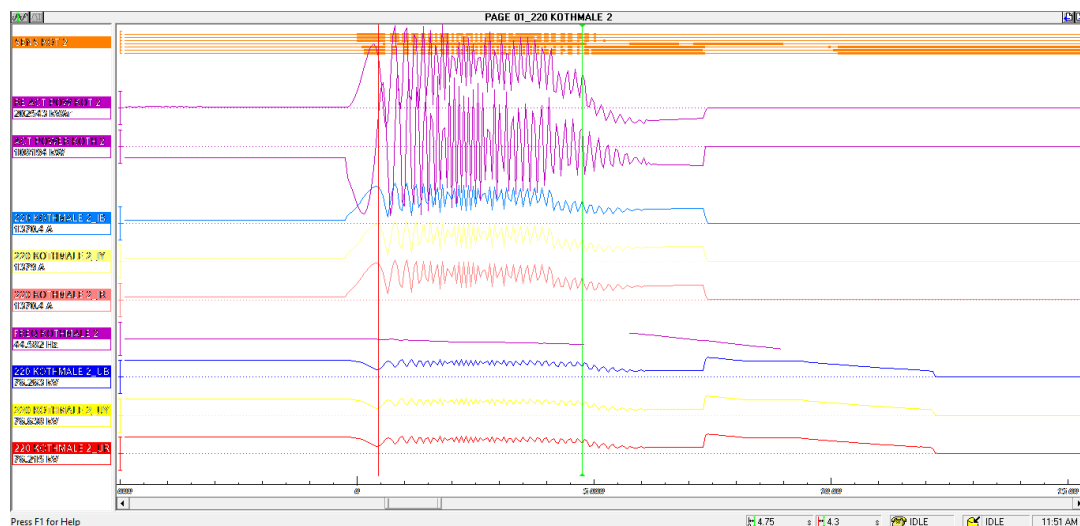
Figure 2.23 - Frequency, Currents, Voltages, Active Power and Reactive Power Variation of Circuit 2 of Kotmale-New Anuradhapura 220 kV Transmission Line

Figure 2.23 shows the frequency variation observed at New Anuradhapura GS, particularly in circuit 2 of Kotmale-New Anuradhapura 220 kV transmission line. It can be seen that the frequency there has decreased from 50 Hz to 44.5 Hz. Therefore, as far as circuit 2 of Kotmale-New Anuradhapura 220 kV transmission line was concerned, there had been a period of about 6 seconds during which the frequency at Kotmale end had been increasing from 50 Hz to 59.5 Hz and the frequency at New Anuradhapura end has been decreasing from 50 Hz to 44.5 Hz. Corresponding to the latter changes in the frequency, substantial fluctuation of currents and voltages, and hence of the active power and the reactive power in the circuit can be observed.

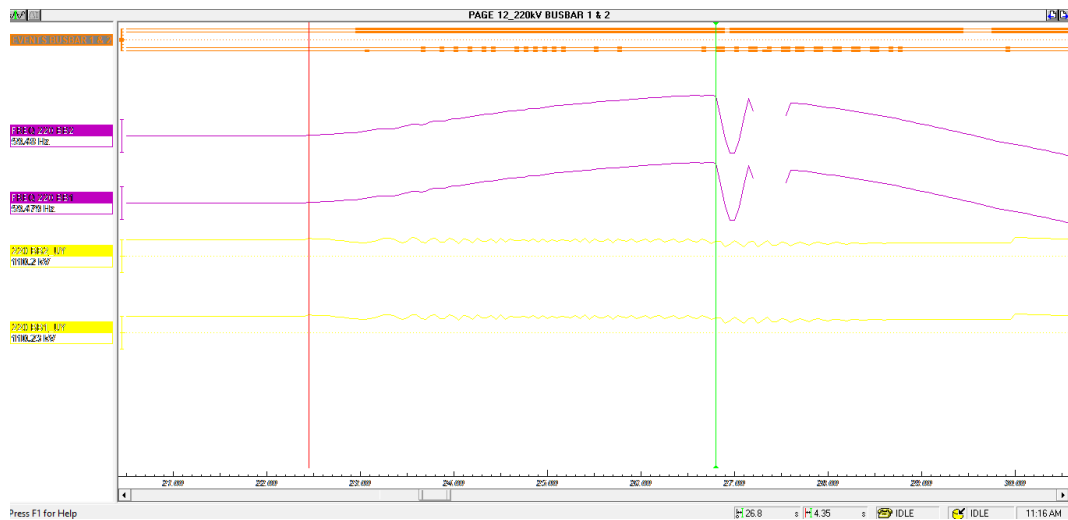
Figure 2.25 - Variation of Frequency recorded at Kotmale Substation

Figure 2.25 shows the 220 kV busbar voltage and the frequency as recorded in the DFR at Kotmale substation. According to Figure 2.25, the frequency rises from 50 Hz to 59.5 Hz following the loss of circuits 2 and then circuit 1 of the Kotmale–Biyagama 220 kV transmission line.

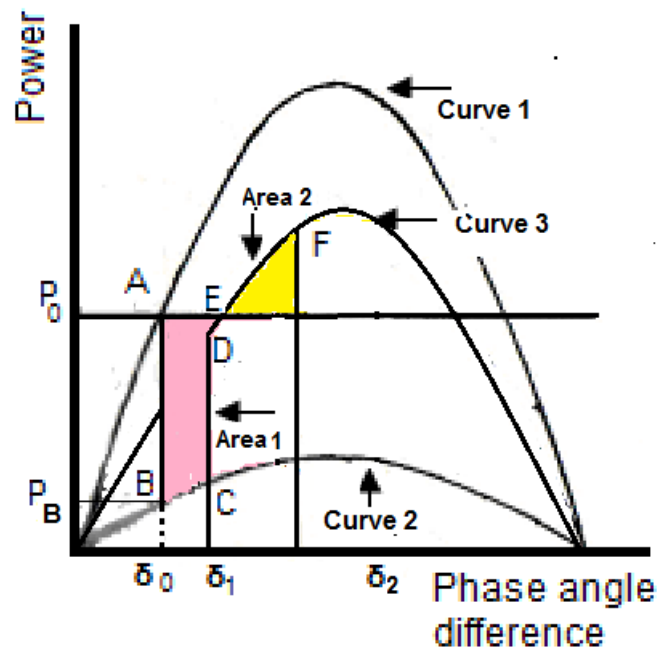
Figure 2.26 - Power Angle Curve

Let us assume that the mechanical power input at LVPP be at P_0 on Figure 2.26. As the system had been in a stable state prior to the fault, mechanical input would have been equal to the electrical output of the generator.

During the fault, value of reactance X will be increased, hence the power transfer will be on a curve of lower amplitude compared to the curve 1. Let the new curve be the curve 2. Due to the lower power transfer of P_B , the operating point will now move to B from A. Power at the LVPP end will be a surplus denoted by $(P_0 - P_B)$ and LVPP generators will speed up while the other group of generators will slow down. Hence, the angle δ increases along the curve 2 until the fault is cleared at point C, and the corresponding phase angle is δ_1 .

From the moment the fault is cleared, curve 3 applies as the fault impedance is no longer present and the system impedance is higher compared to its original value. The new operating point will be D and still there will be a surplus of power at LVPP, and angle δ continues to increase along the curve 3. When the operating point passes point E, mechanical input from LVPP becomes less than the electrical output and LVPP machines will start to slow down while the other group will start to accelerate. However, LVPP machines will continue to speed up due to inertia, until they reach the point F where the two groups of machines will run at the same speed.

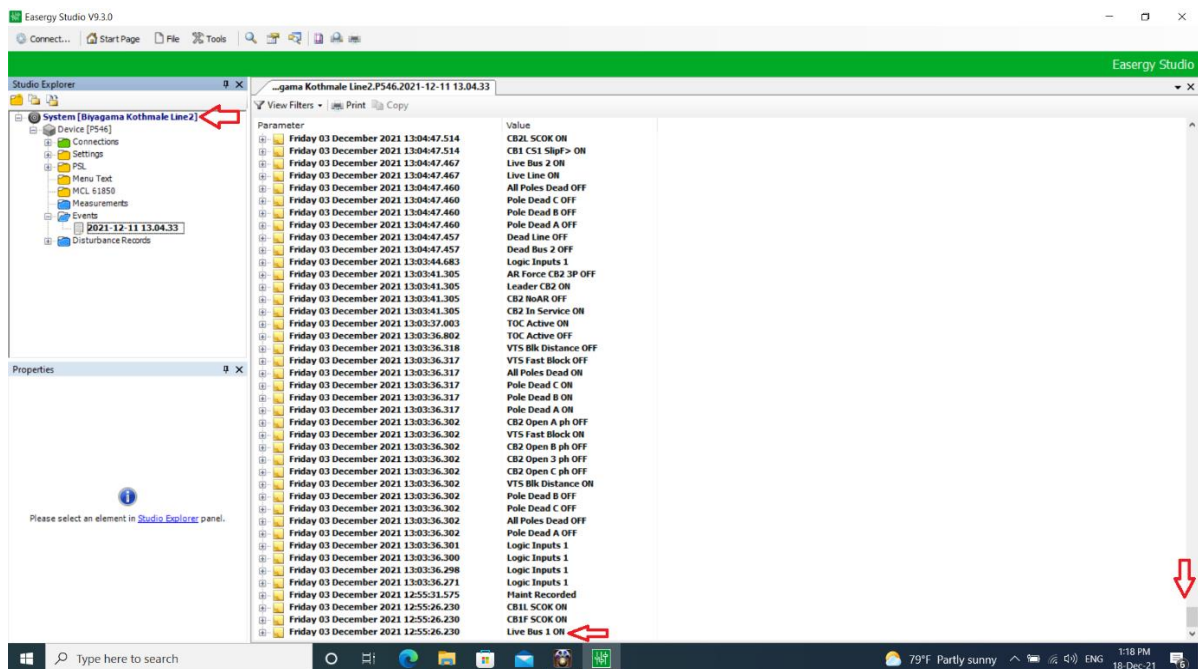
Figure 2.28 - Main 2 Relay Records taken Electronically at Kotmale Substation on Circuit 2 of Kotmale-Biyagama 220 kV Transmission Line

The Committee was surprised to learn that when the same Main 2 Relay records at Kotmale substation was accessed electronically using the Easergy Studio V9.3.0 on December 11, 2021, there were no records before 12:55:26.230 on December 03, 2021 for circuit 2 (reproduced in Figure 2.28) and no records before 10:15:23.951 on December 03, 2021 for circuit 1 (reproduced in Figure 2.29). This discovery was made just two days after receiving the records from the CEB as pdf files on the request of the Committee. The records downloaded from the relays were received in their respective file formats during the visit to Kotmale substation on December 11, 2021 and the explanation received on the missing records was that a possible overwriting may have taken place due to short internal memory storage capacity of the relay. However, CEB engineers have not shown us any statement in the manufacturer's literature that confirmed this position. In addition, we also noted that the time zone of the clock used on these relays was GMT but not GMT+5:30 (applicable to Sri Lanka), which should have been corrected to ensure integrity of data recorded in different equipment.
