**Response of CEB to the Final Report of the
committee appointed by the Ministry of
Power to investigate power system failures
on November 29, 2021 and December 03,
2021**

25 March 2022

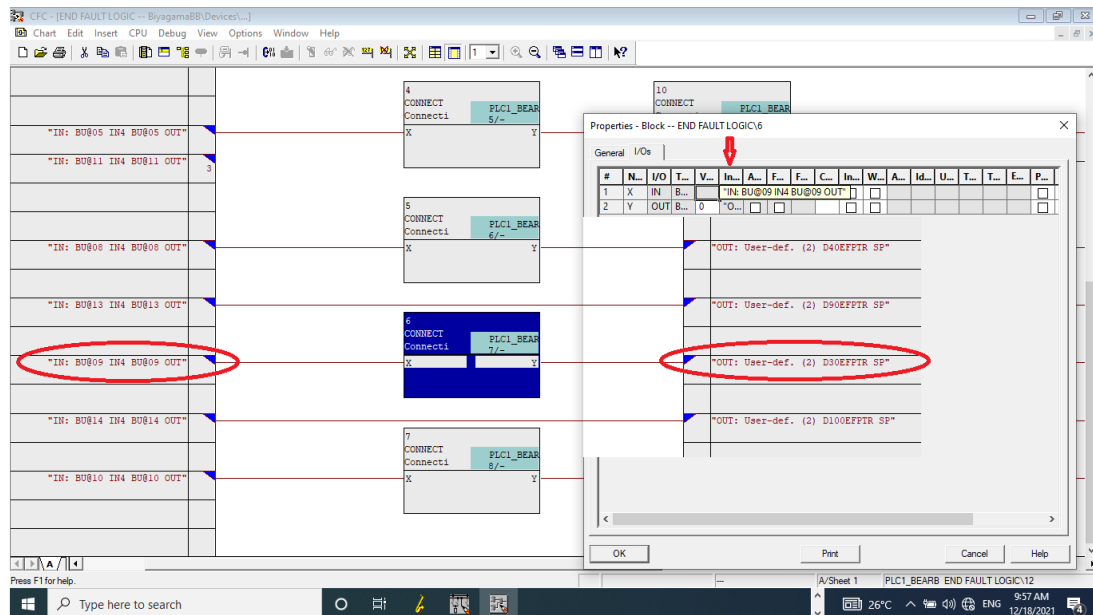
Figure 4.2-1 CFC logic diagram of End-Fault Function Implementation in the SIEMENS 7SS522 Relay

The Committee studied the end-fault logic implemented in SIEMENS 7SS522 relay from the records in the relay accessed using DIGSI V4.93 software. Figure shows the screenshot highlighting the output generated by the D30EFPTR using the relay function block. The properties of the function block reveal that only the neutral current (IN) is taken as the input. Accordingly, when IN exceeds a certain threshold, the end-fault tripping is activated.

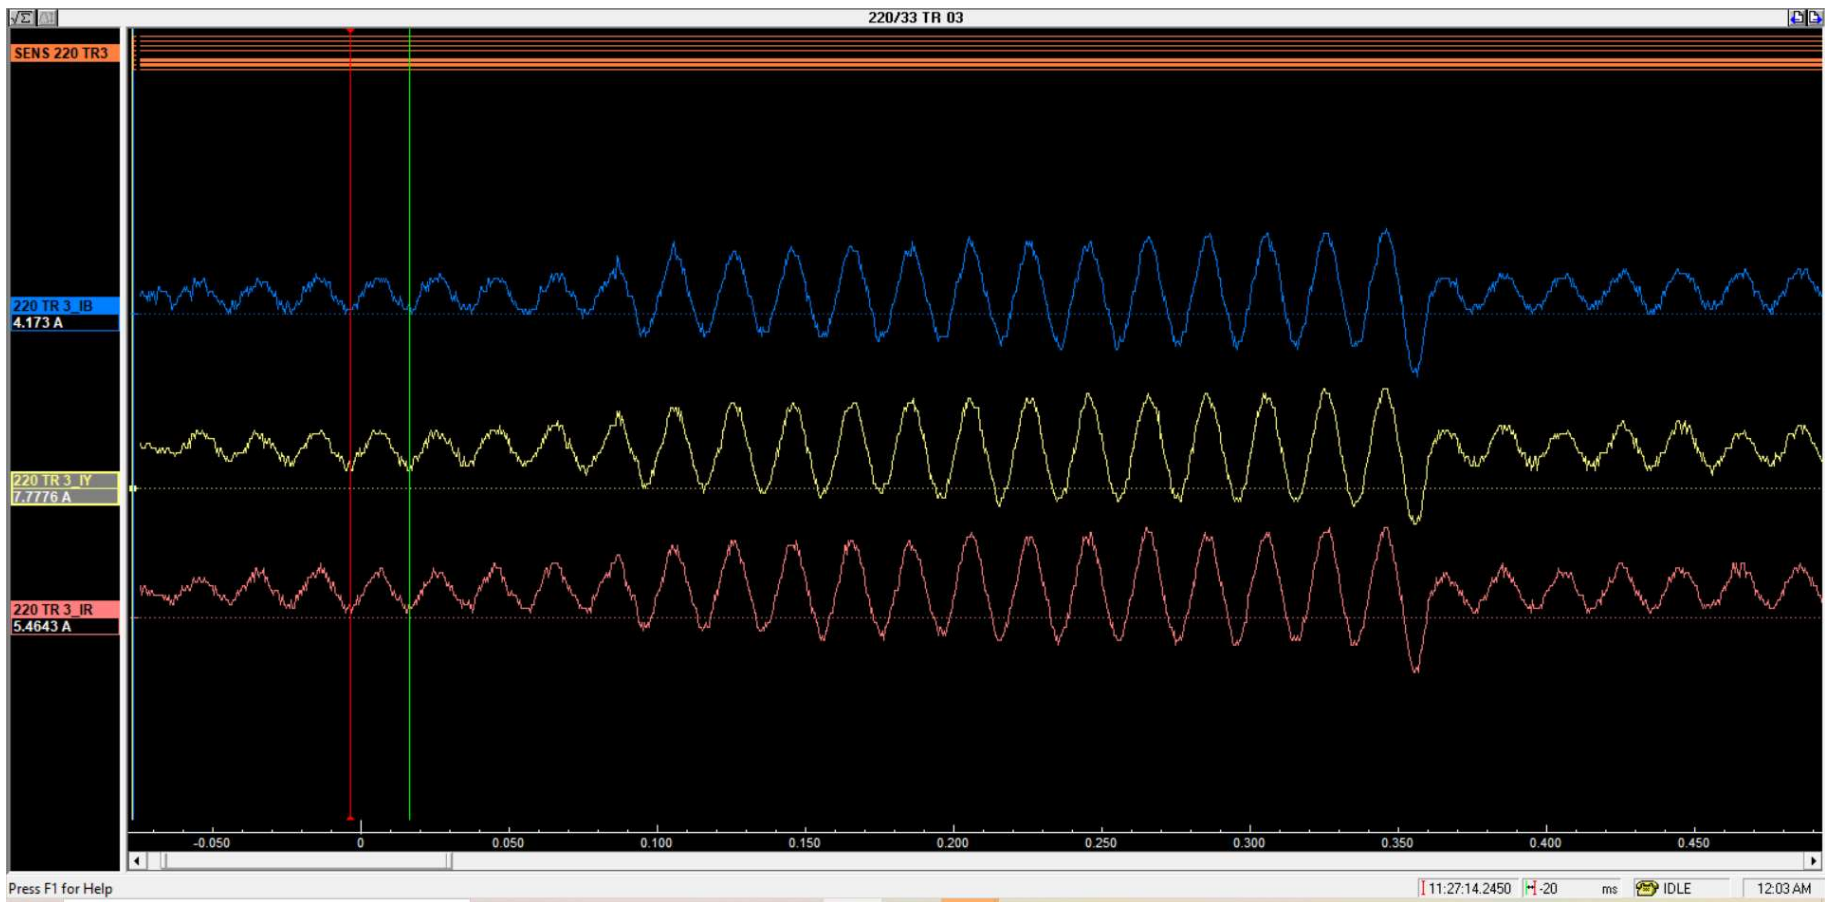
R, Y, B Current of 220/33 kV TF 3 at Biyagama GS

The 33 kV CB was in OFF position & 220 kV CB was in closed position during the fault, so the Zero Sequence current flows through the 220 kV neutral of the TF and through all the 220 kV phases during the fault.

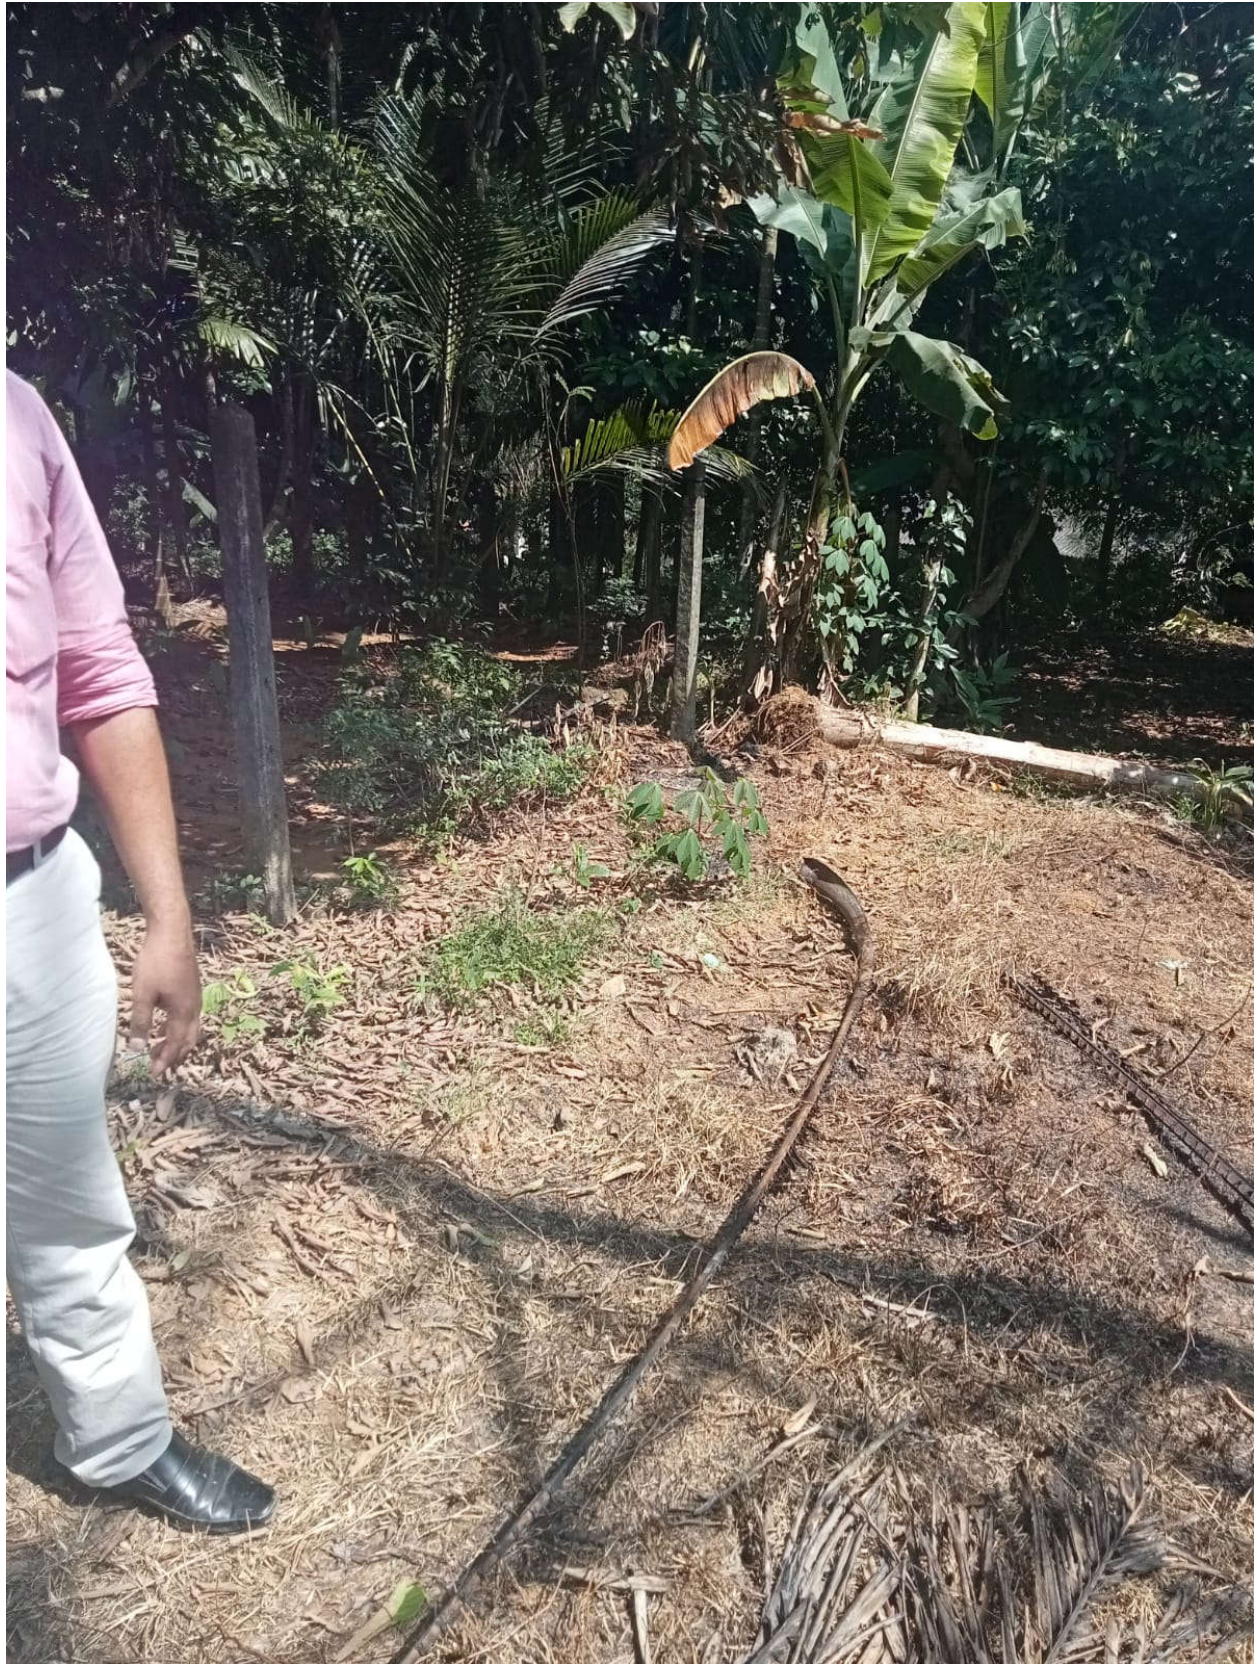
Burnt leaves of near by tree confirming that the fire has been substantial

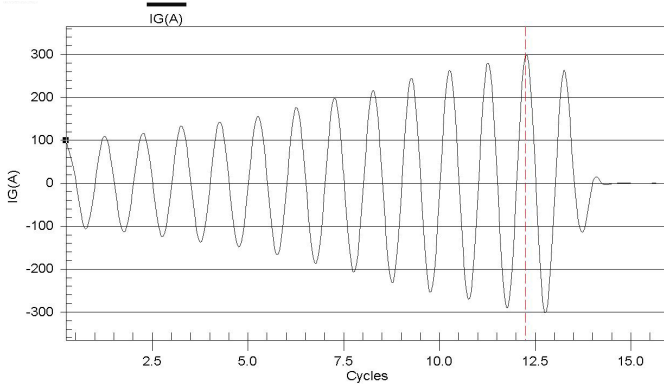
Fig. 2. Ground current at Terminal A

The first fault was characterized as a high-impedance fault with gradually rising ground current. Several cycles after the start of the fault, the current reached the minimum protection threshold. Fig. 2 displays the ground fault current as seen from Terminal A.

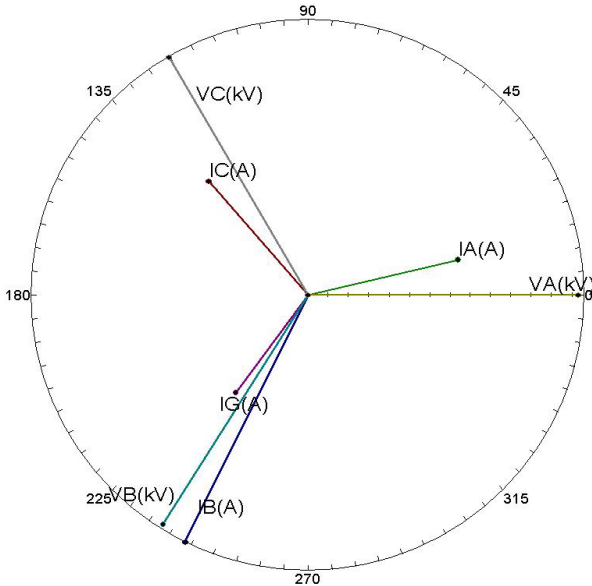
Fig. 3. Voltage and current phasors

Fig. 3 displays the voltage and current phasors as seen from Terminal A at the moment the relay tripped. There was practically no voltage sag for the faulted phase. With a high-impedance fault (hundreds of ohms), the angular difference between the B-phase voltage and the B-phase current is between -5° and -10° . Fig. 3 shows a predominantly resistive characteristic.

When the observed current presents such a resistive angle, the fault is a high-impedance (resistance) type. The I_B phasor is the sum of the prefault load current and the Thévenin's short-circuit current.

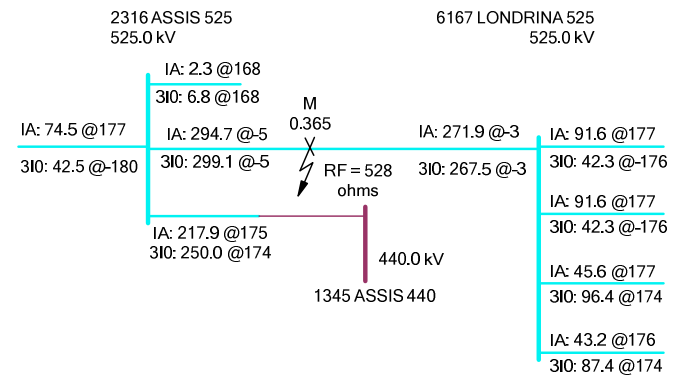
Fig. 4. Fault modeling

Using a short-circuit calculation program, protection engineers estimated R_F and the fault location. The system data used for the calculation were obtained from the Brazilian National Interconnected System Operator (ONS). Fig. 4 shows the calculated currents with 528 ohms of R_F .

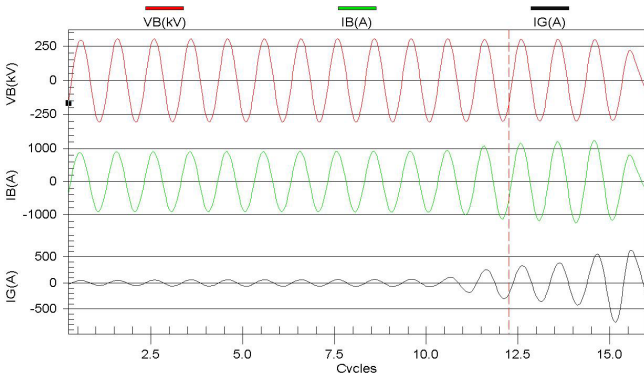
Fig. 8. VB, IB, and IG waveforms

This fault involved a tree and was characterized by very high resistance. The faulted phase voltage and current and the residual current are displayed in Fig. 8.

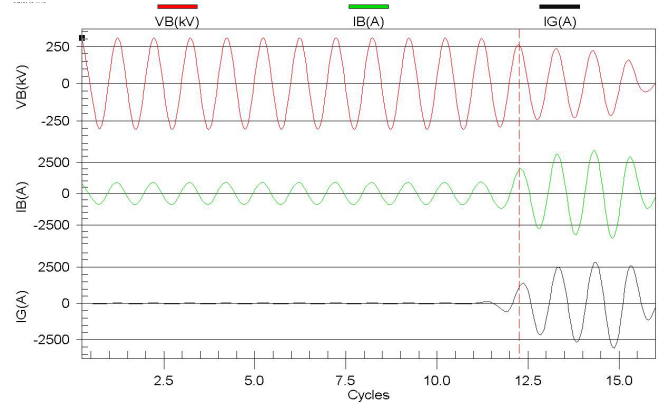
It was observed, in this case, that the B-phase-to-ground fault involving a tree was a classic short circuit with high current and voltage sag at faulted phase, as shown in Fig. 9.

Fig. 9. VB, IB, and IG waveforms show more current and voltage sag at the fault due to the lower impedance fault

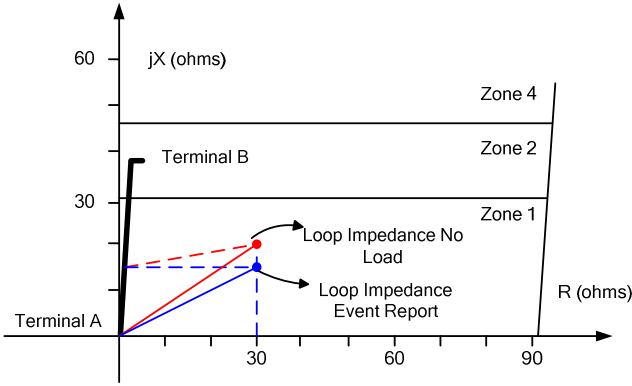
Fig. 10 shows the calculated impedances, from Table XX, in comparison to the reach of the distance zones. Out of all of the occurrences described in this paper, this event is the only one for which the distance protection function tripped the transmission line.

The fault locator of the relay indicated 47 kilometers for a 44.8-kilometer location.

Fig. 10. Distance element and fault point at Terminal A

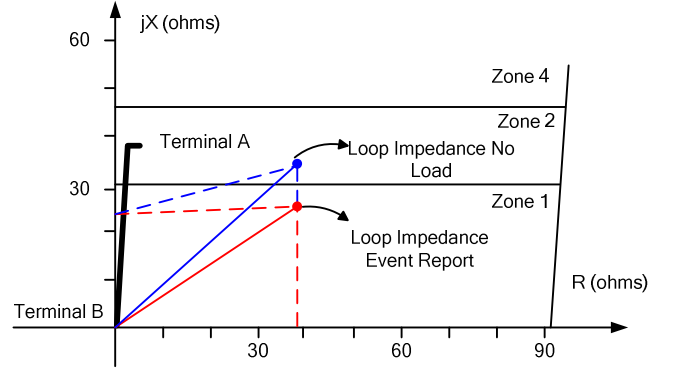
The calculated reactance shows the influence of the load. With load, the apparent impedance is inside Zone 2. Without load, the fault would be in Zone 1 (physically to 64 percent of the transmission line). The fault locator indicated 76.9 kilometers for a 78-kilometer location, as shown in Fig. 11.

Fig. 11. Distance element and fault point at Terminal B
